Russell Anderson's report on Leadburn Block

Visited on 4th and 11th December 2013

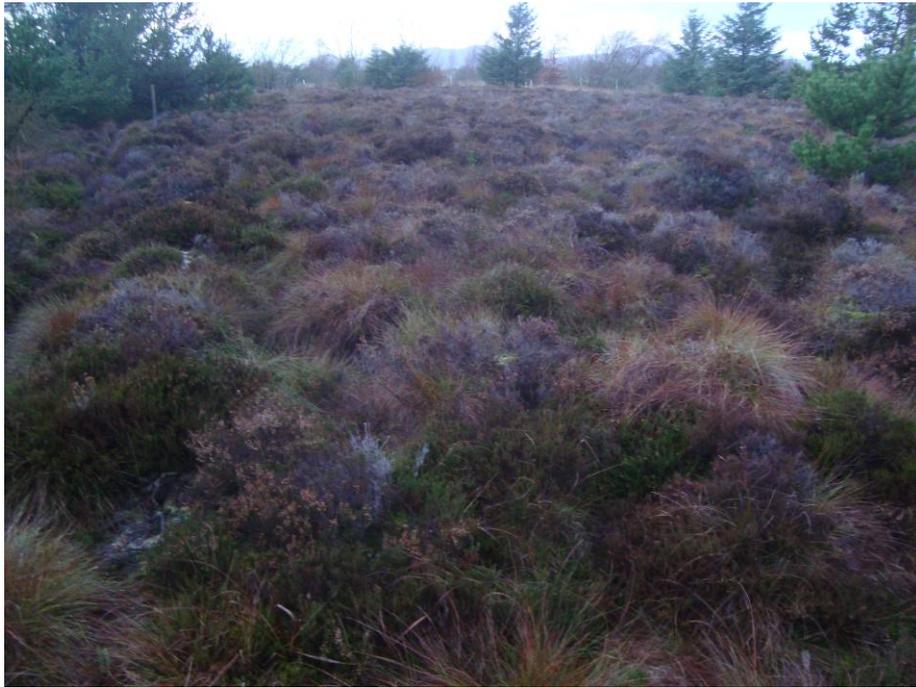
The northern area is rather heather-dominated (Figure 2) but away from drains, it has a high cover of Sphagnum moss (mainly *S. magellanicum*, *S. papillosum* and *S. capillifolium*) and supports good M18 bog vegetation in places (Figure 3). The heather dominance is probably due to the drying influence of the forest and drains on the adjacent peat. Although there are deer in the research area now, they were excluded for many years and this will have favoured the heather.

Figure 2. Heather-dominated bog with conifer regen at the north end of the site.

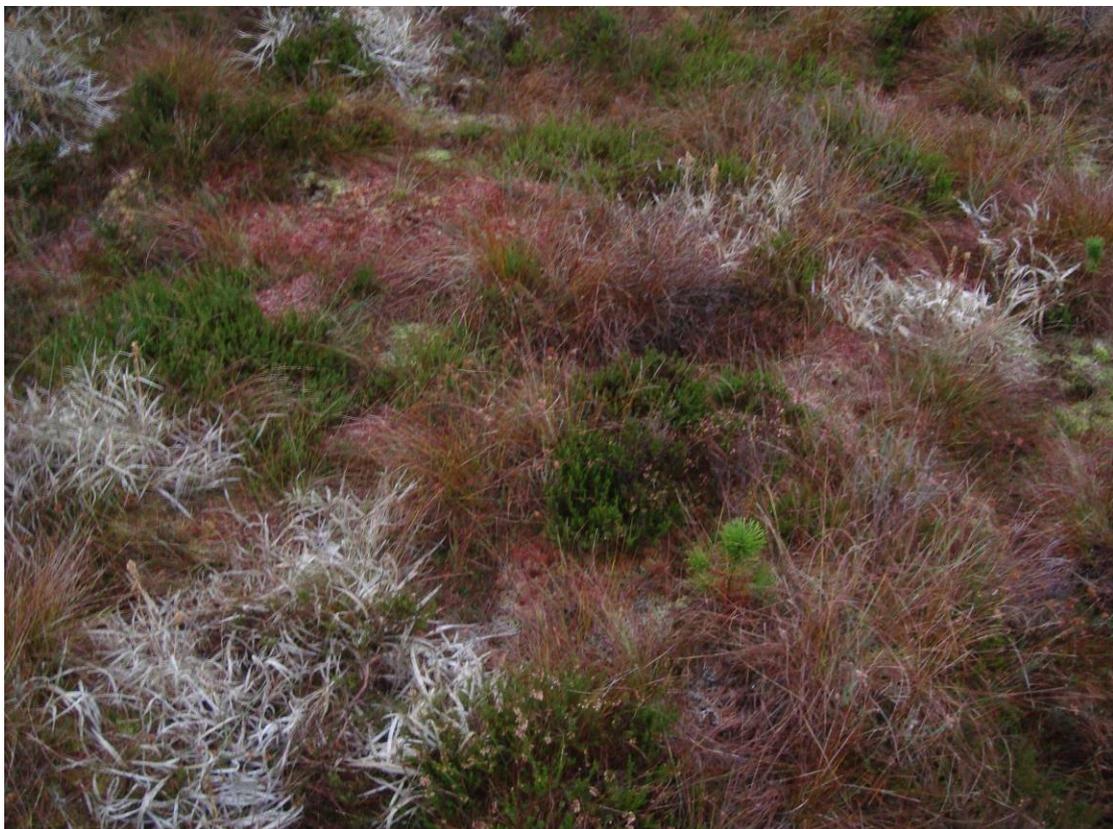
Figure 3. Some of the open ground at the north end of the site is less heather dominated and has a good mixture of bog species, including bog asphodel and magellanic bog-moss *Sphagnum magellanicum*.

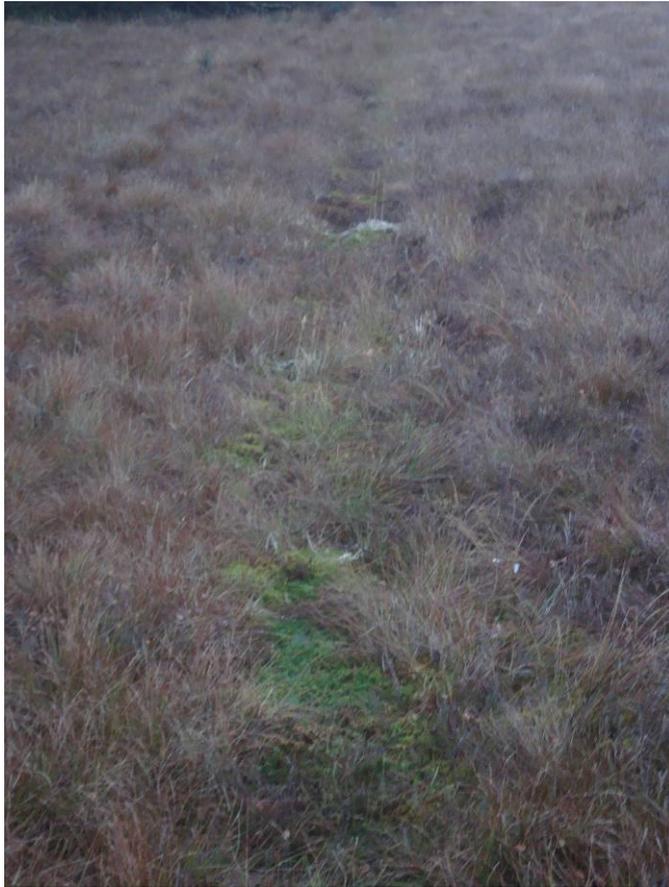
The open bog across the fence to the east of the block is in quite good condition. It has been drained but the drains have largely filled with Sphagnum (Figure 4) and are now pretty ineffective. These old drains would be virtually invisible were it not for the profuse growth of bog asphodel *Narthecium ossifragum* alongside them (Figure 5). In contrast to the open bog inside the fence, this area of bog has very short vegetation, probably because it has been quite heavily grazed. Heather is abundant but

Figure 4. Open bog on neighbouring land to the east was drained in the past but the drains, filled with Sphagnum, are now ineffective.

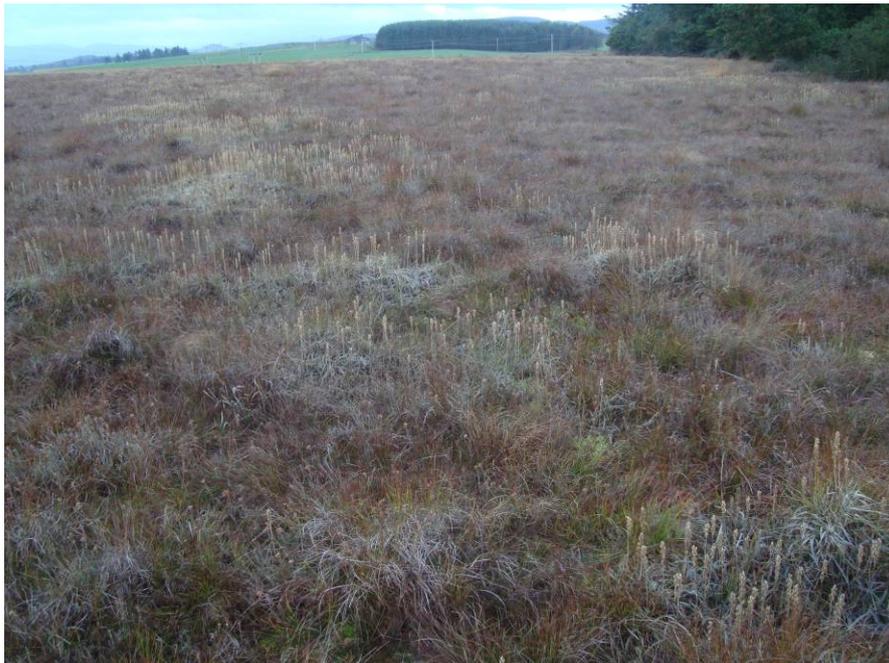
Figure 5. Some of the old drains on the land to the east are only detectable by the patches of bog asphodel growing alongside them.

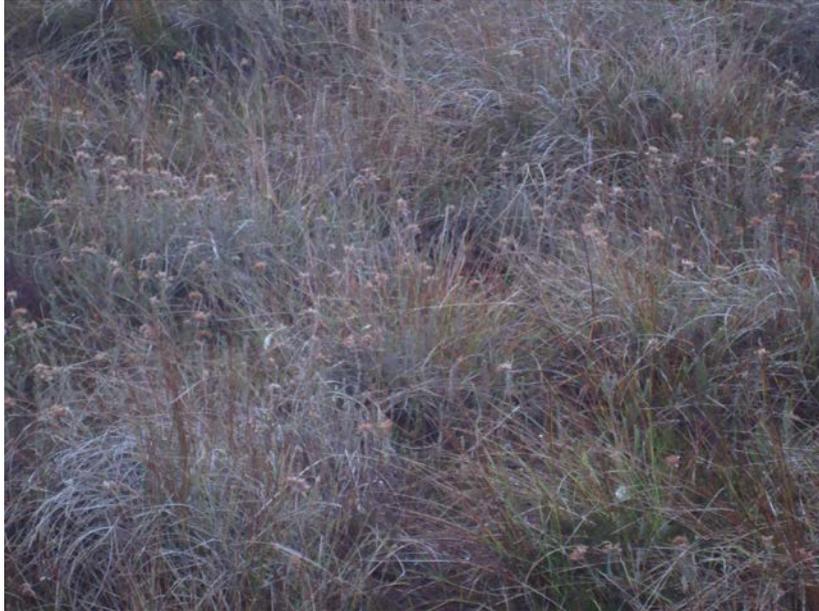
not dominant, due to its cropped condition. Cross-leaved heath *Erica tetralix* is at least as abundant if not more so (Figure 6). Deer grass *Scirpus cespitosus* is fairly abundant and more obvious here than inside the fence, perhaps being favoured by the grazing. The surface is rather even, lacking the hummock/hollow micro-topography found in really good condition bog habitat.

Figure 6. The vegetation on adjacent land to the east is cropped quite short and much of it is dominated by ?? and cross-leaved heath.

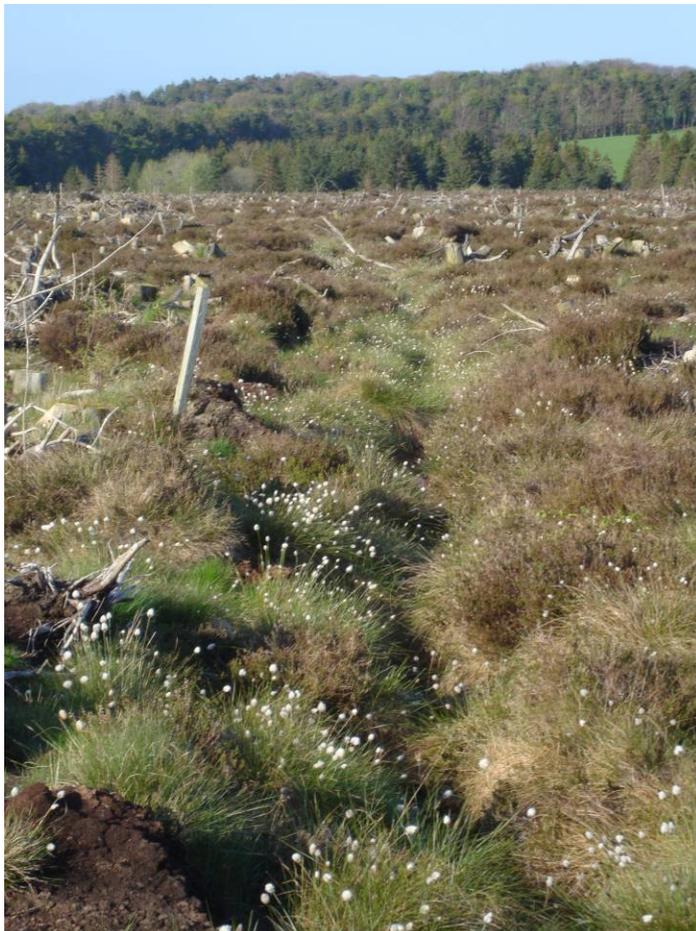
The restored raised bog to the west of the disused Dolphinton Railway, part of the Leadburn Community Woodland, is still at quite an early stage of restoration because it was left fallow for a few years before the Community Group bought the site, decided to restore the bog and succeeded in bidding for funding for the work. The drains have been dammed, the conifer and birch regen cleared and it is now recovering very well (Figure 7). The site is still a bit drier than is ideal but on the whole the restoration is a success.

Figure 7. Restored bog on land to the west managed by Leadburn Community Woodland Group. Photo taken April 2011.
