Central Mull LMP - Issues

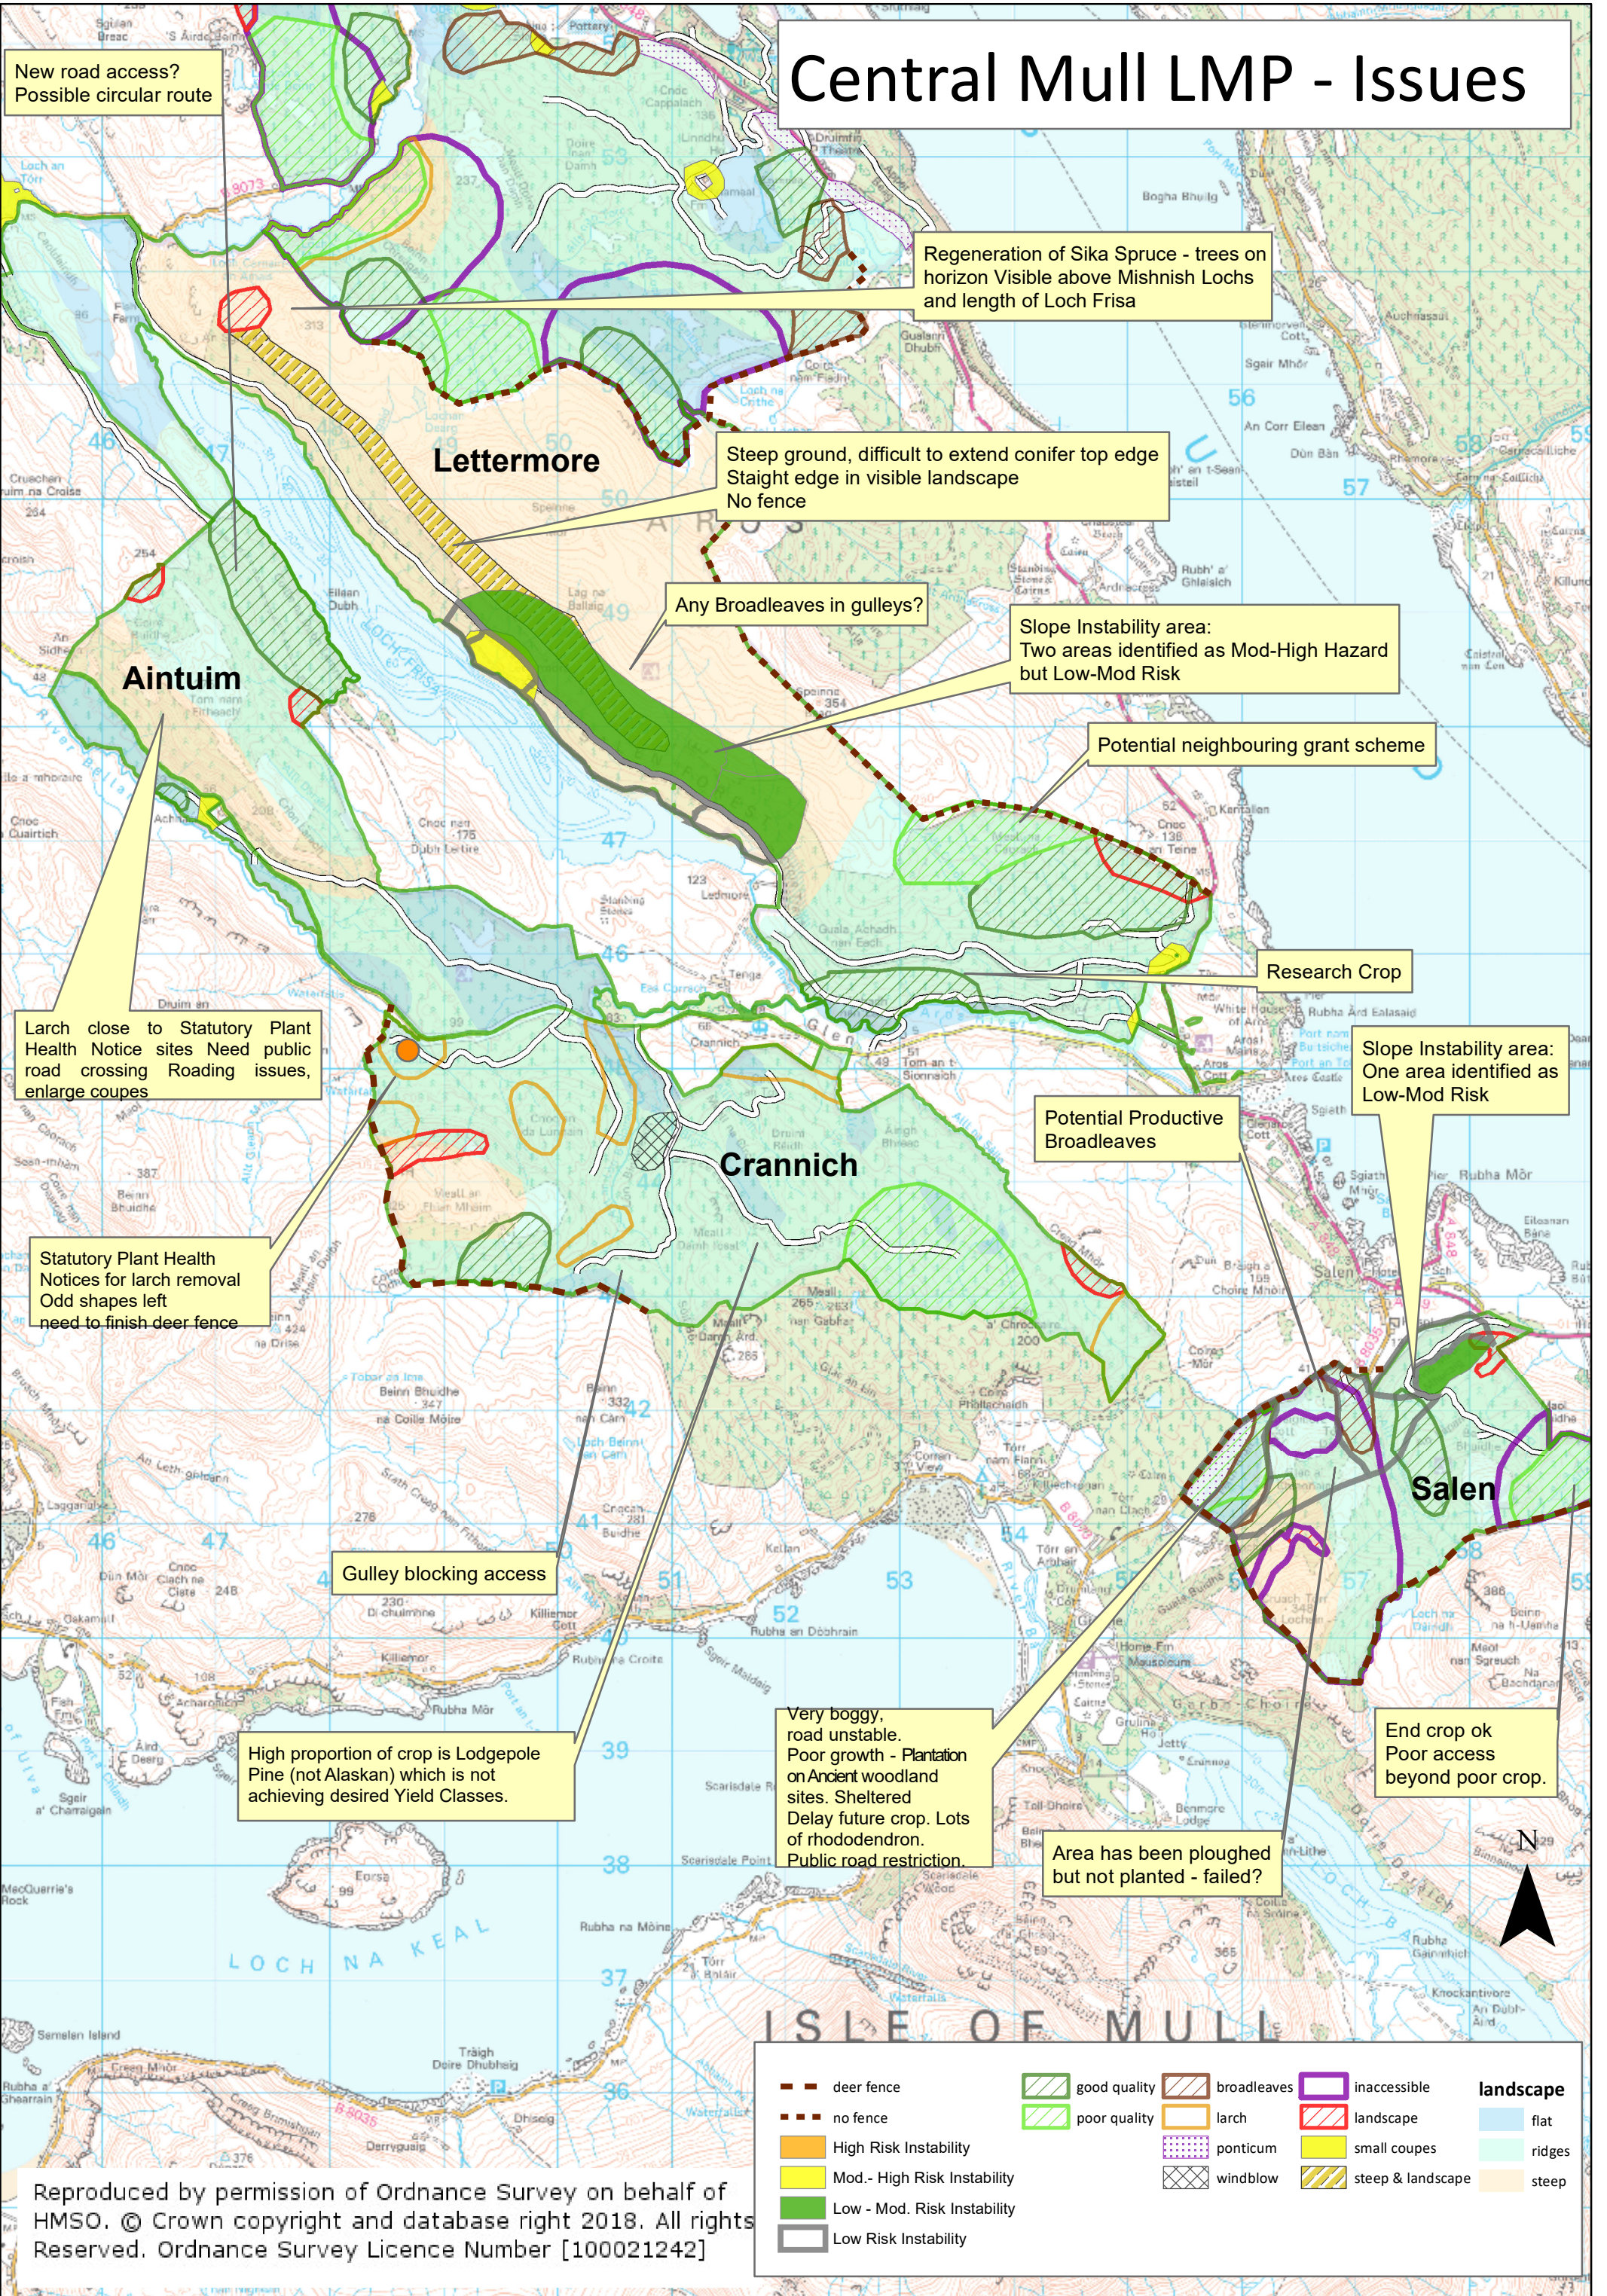
New road access?
Possible circular route

Regeneration of Sika Spruce - trees on horizon Visible above Mishnish Lochs and length of Loch Frisa

Steep ground, difficult to extend conifer top edge
Straight edge in visible landscape
No fence

Any Broadleaves in gulleys?

Slope Instability area:
Two areas identified as Mod-High Hazard but Low-Mod Risk

Larch close to Statutory Plant Health Notice sites Need public road crossing Roding issues, enlarge coupes

Slope Instability area:
One area identified as Low-Mod Risk

Statutory Plant Health Notices for larch removal
Odd shapes left
need to finish deer fence

Gully blocking access

High proportion of crop is Lodgepole Pine (not Alaskan) which is not achieving desired Yield Classes.

Very boggy, road unstable. Poor growth - Plantation on Ancient woodland sites. Sheltered Delay future crop. Lots of rhododendron. Public road restriction.

Area has been ploughed but not planted - failed?

End crop ok
Poor access
beyond poor crop.
