Phase I Land Quality Appraisal
Westfield Farm, Caldercruix, ML6 7RY
Client: Forestry Commission Scotland

Date: 11th June 2012

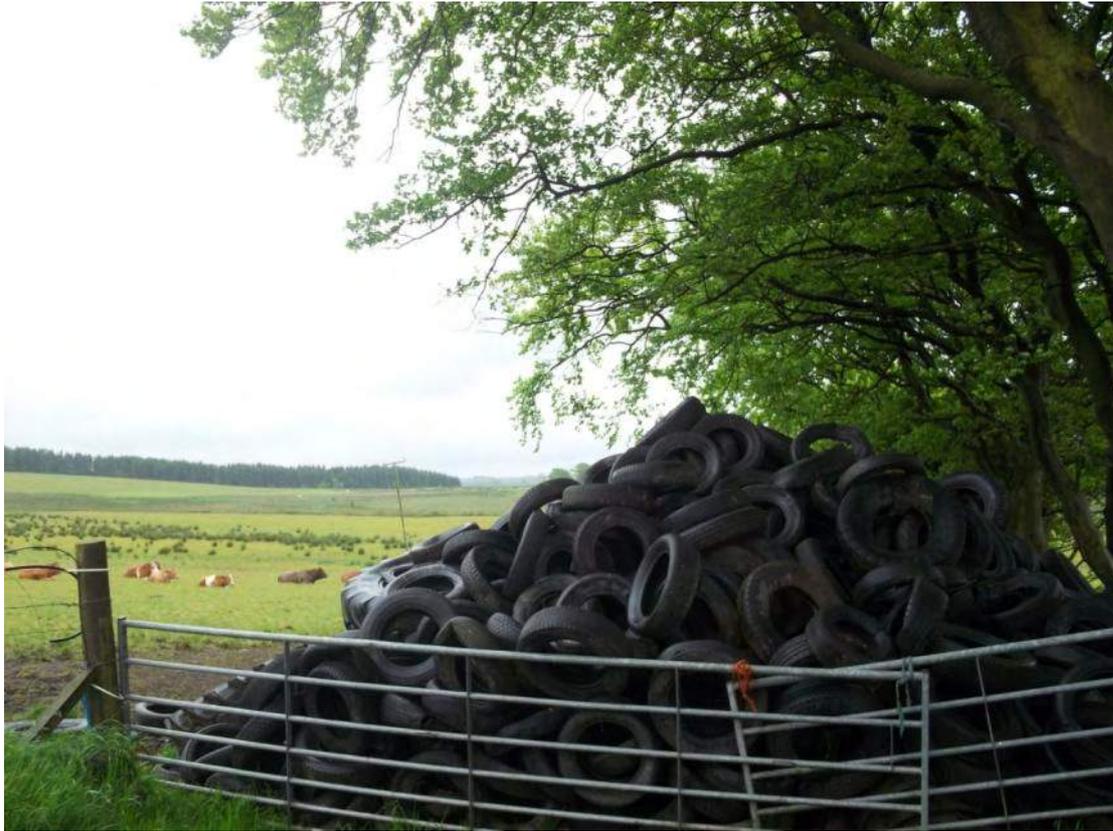
Lot 3 slopes gradually from north to south. A large pile of tyres were observed in the western area of field 8. The northern area of field 25 is covered by dense mature trees. An area of poorly drained peat is contained within field 14. Field drains are present along the boundaries of most fields and along either side of the track.

Figure 1 – Pile of tyre on western end of field 8.

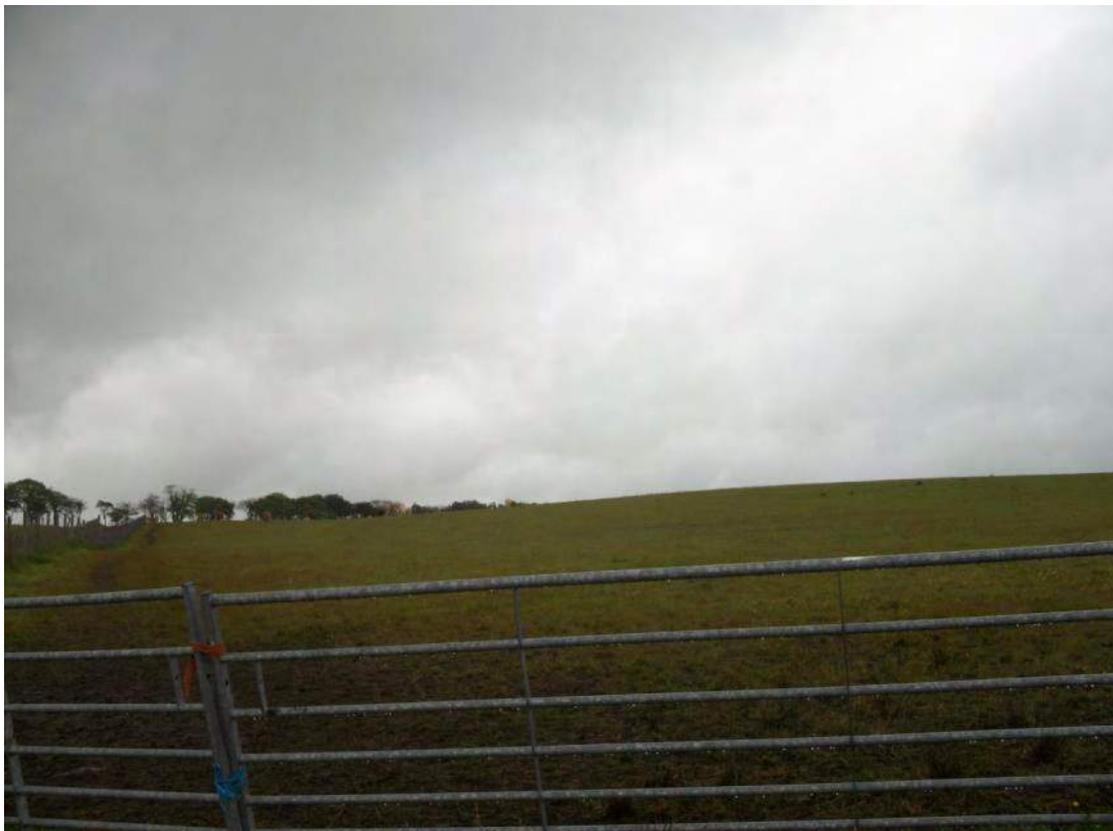
Figure 2 – Looking west-east across the north of field 8.

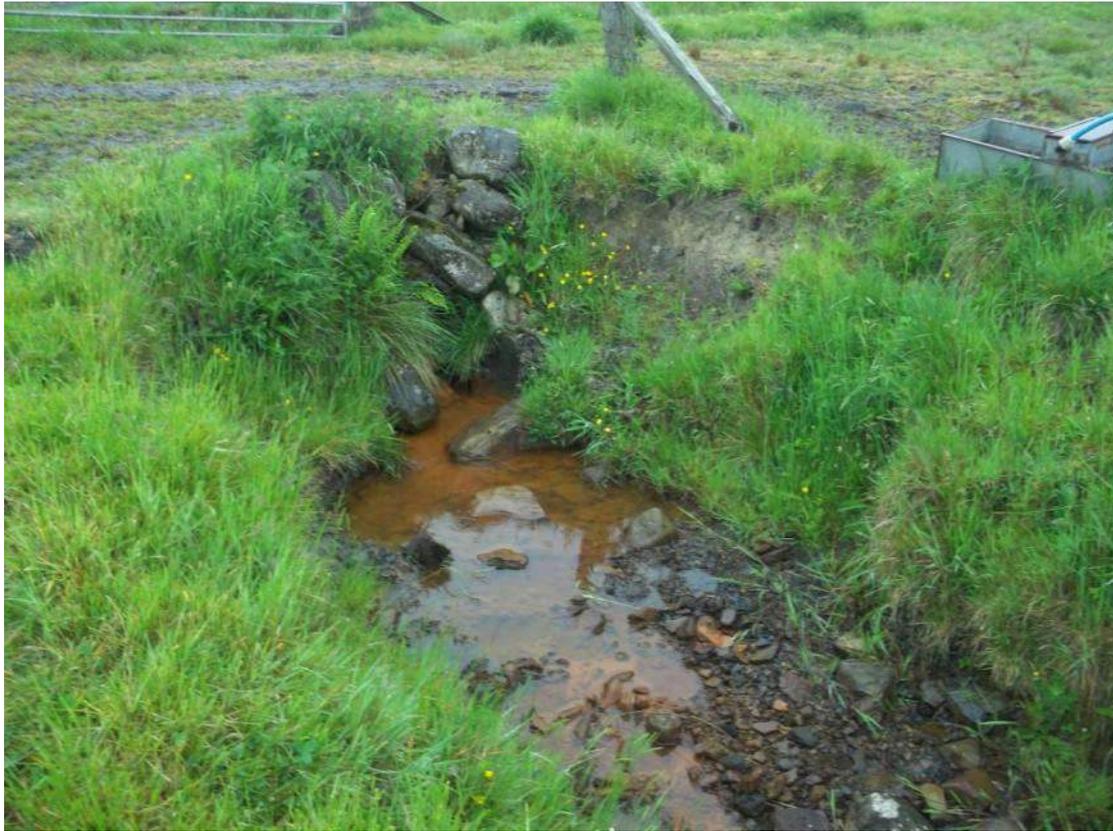
Figure 9 – Field drain exiting culvert under track at boundary of fields 17 and 24.

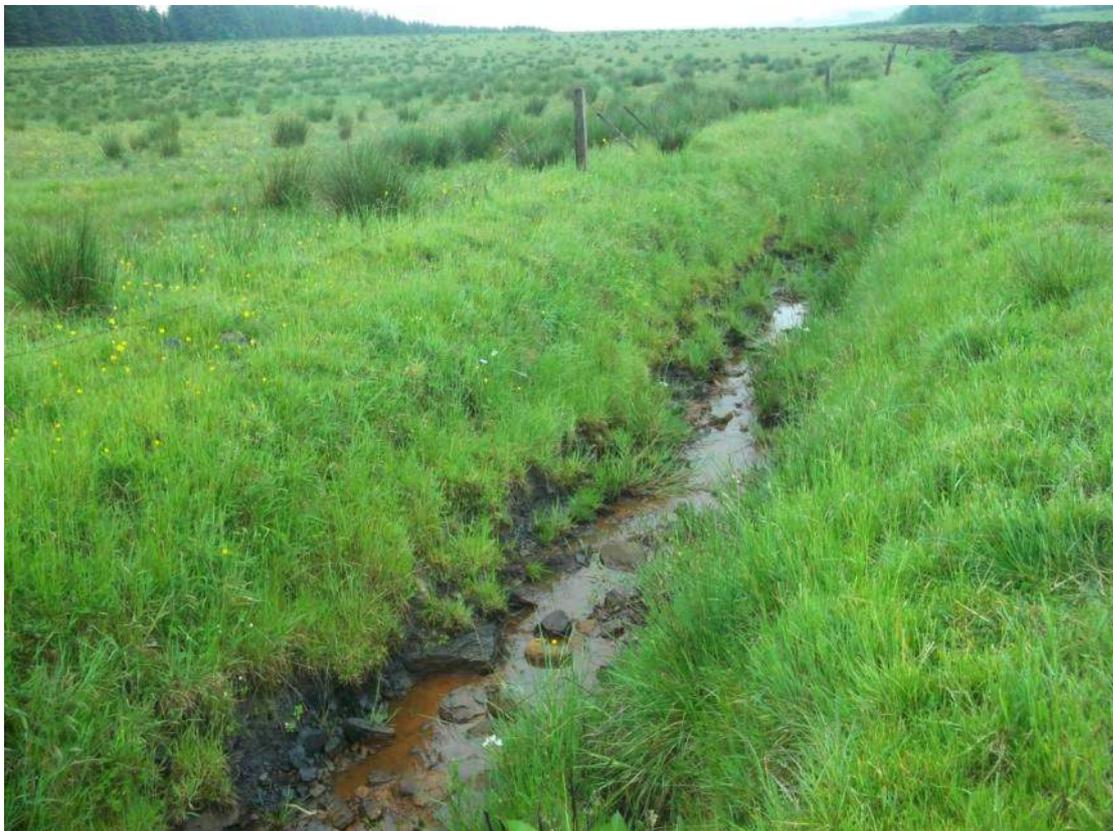
A field drain which emerges from the southern end of field 23 and runs under the track and into the field drain along field 24 was noted to have discolouration indicative of iron oxide presence. This discolouration was observed for approximately 20m along the field drain (photos contained in Appendix B) after which water in the field drains runs clear.

Figure 10 – Looking from north-south along field drain (between fields 24 and 17) showing water discolouration.

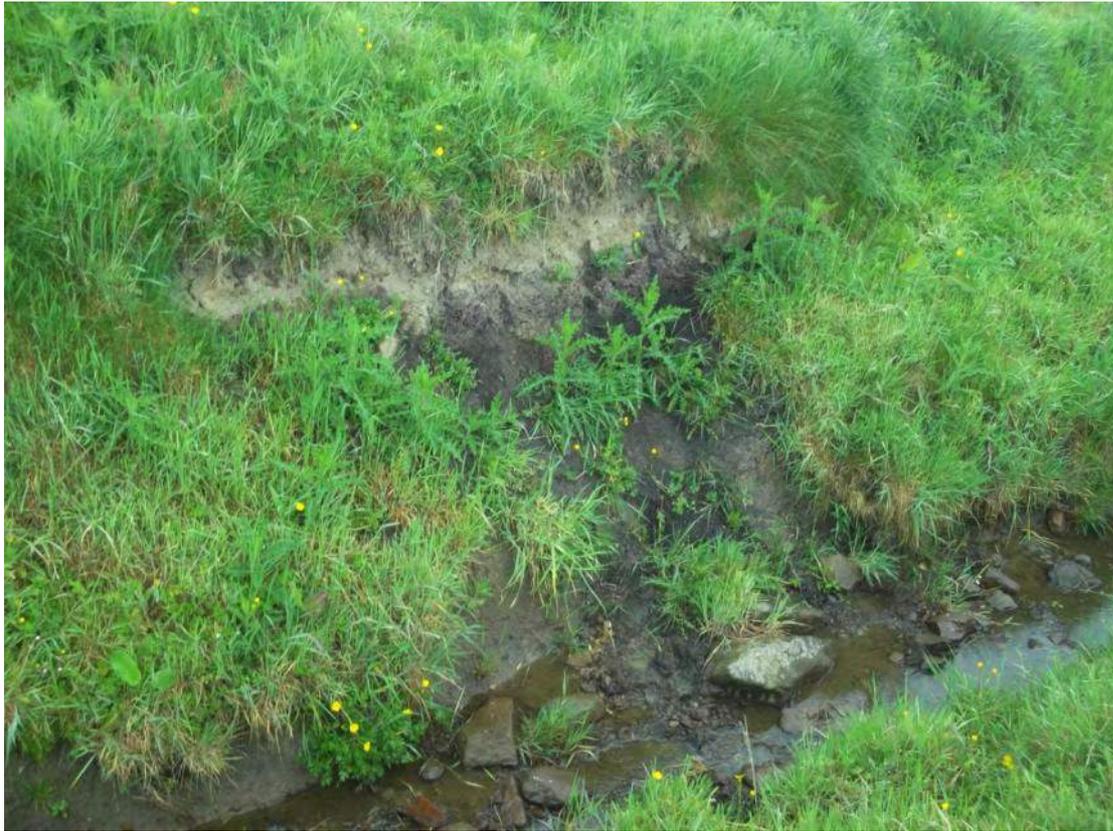
Figure 11 – Bank of field drain along field 17 showing underlying drift geology.

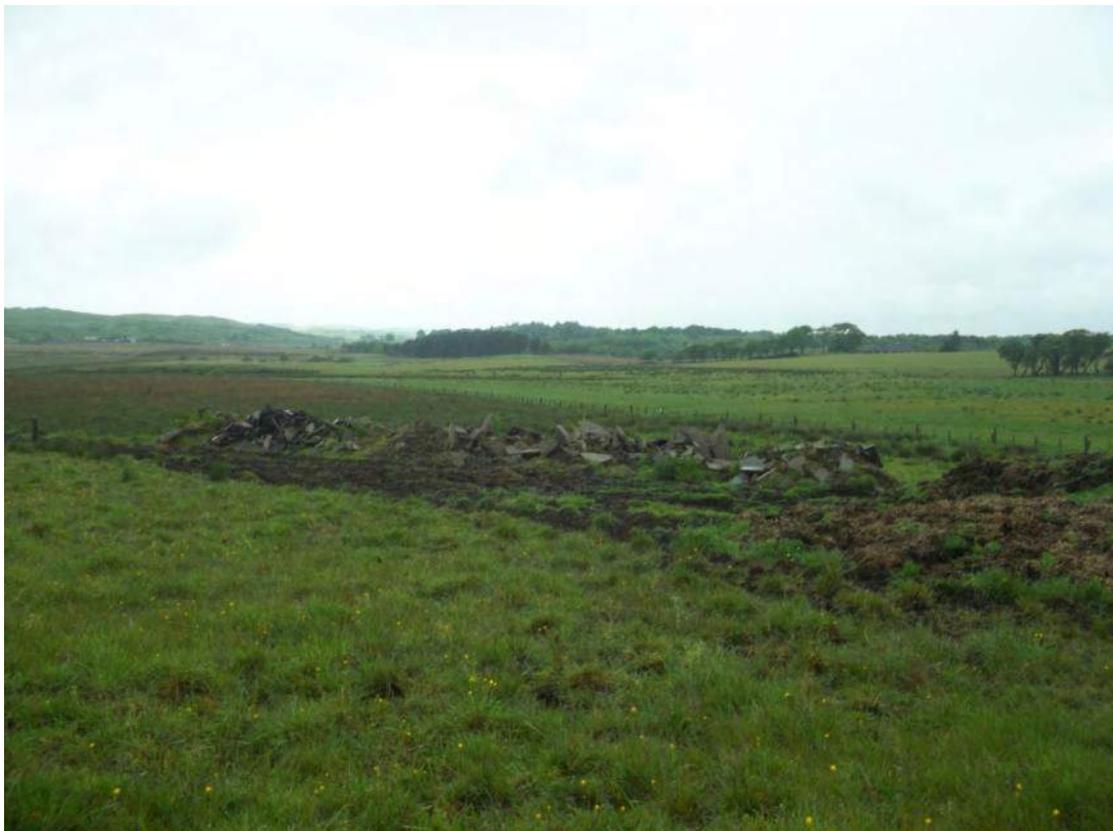
The track itself is constructed of gravel, broken pieces of tarmac and blaes. Large piles of manure were observed within fields 24 and 25. Piles of construction debris of unknown provenance which include worked granite slabs, slate,

Figure 12 – Pile of manure and construction debris on track between fields 19 and 24.

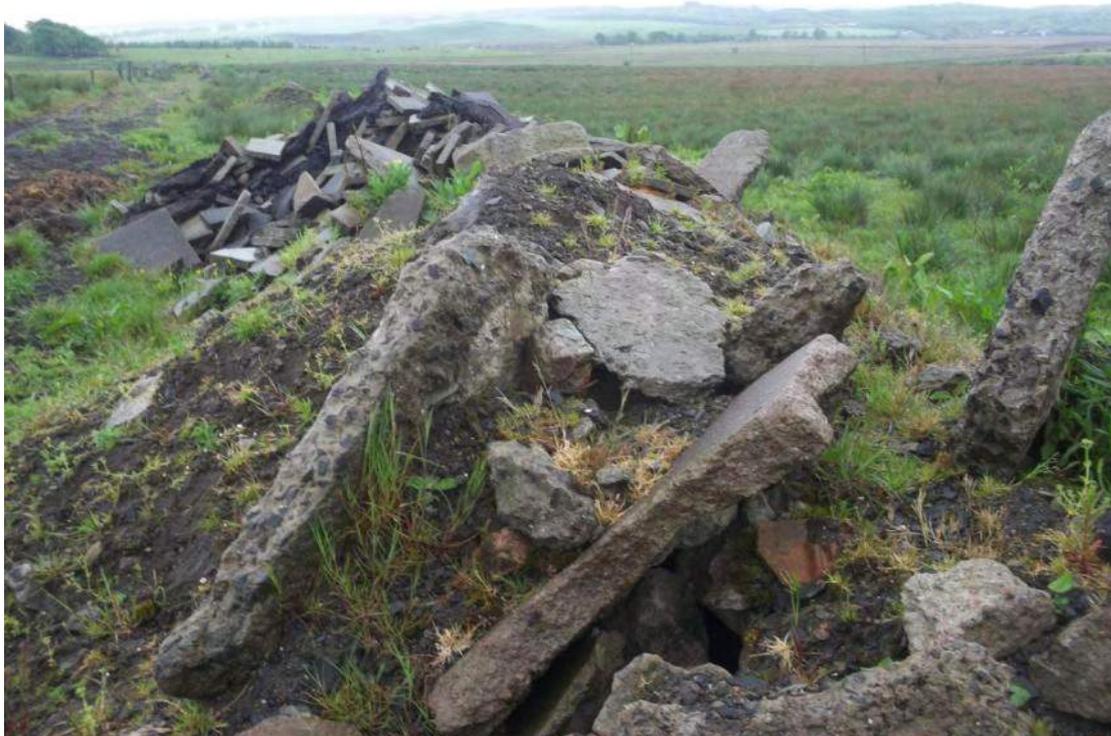
- No asbestos report or asbestos management plan (AMP) was available for inspection on-site yet no ACMs were observed during site reconnaissance. However small piles of construction debris and areas of made ground of unknown provenance were observed which have the potential to contain asbestos.

Figure 13 – Construction debris between fields 19 and 24.

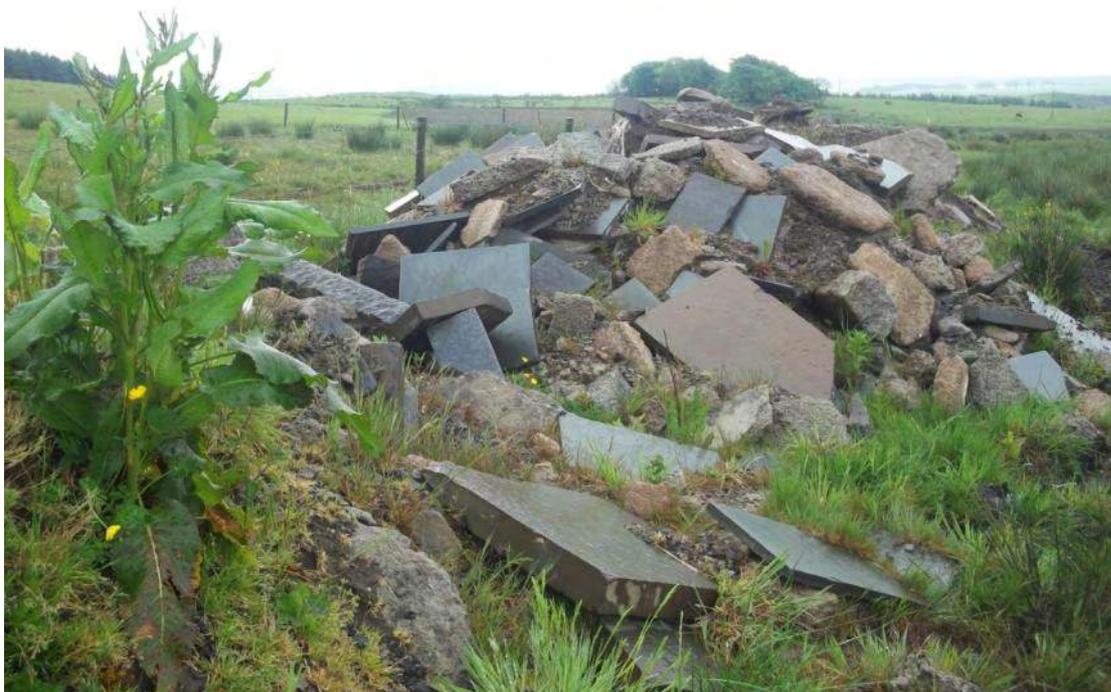
Figure 14 – Construction debris between fields 19 and 24.

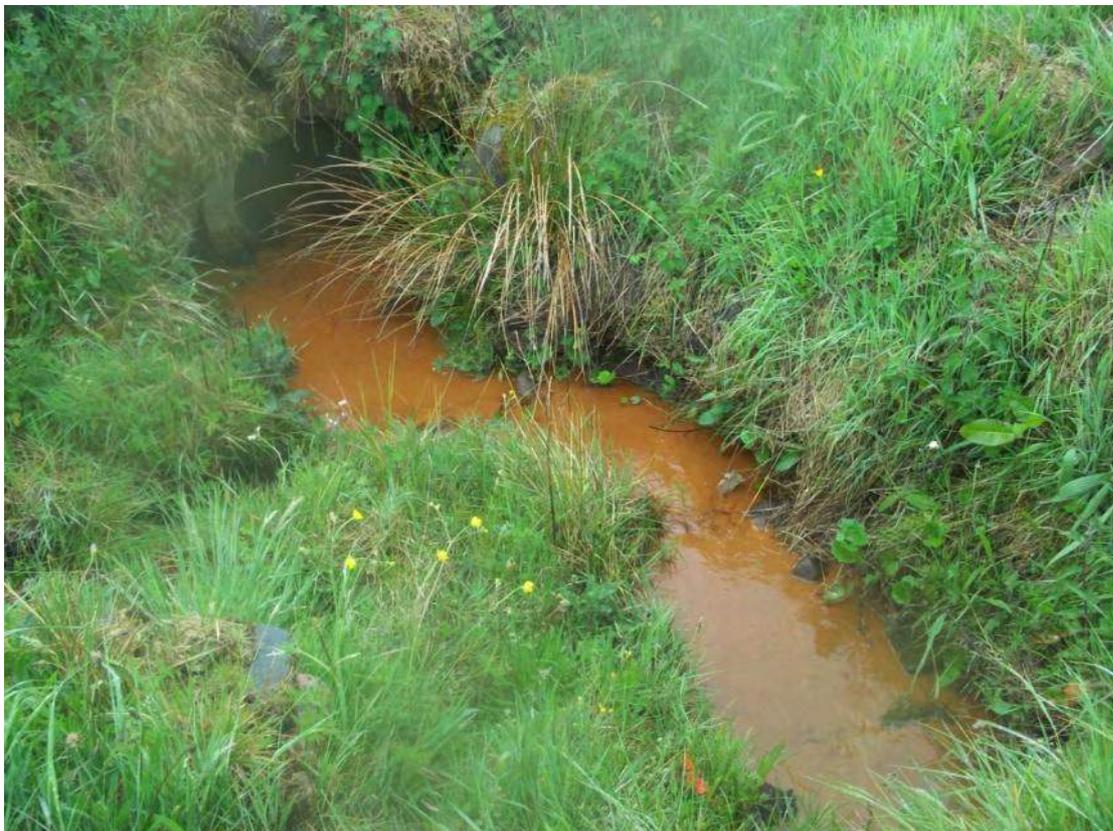
Figure 18 – Field drain at southern end of field 23 showing water discolouration.

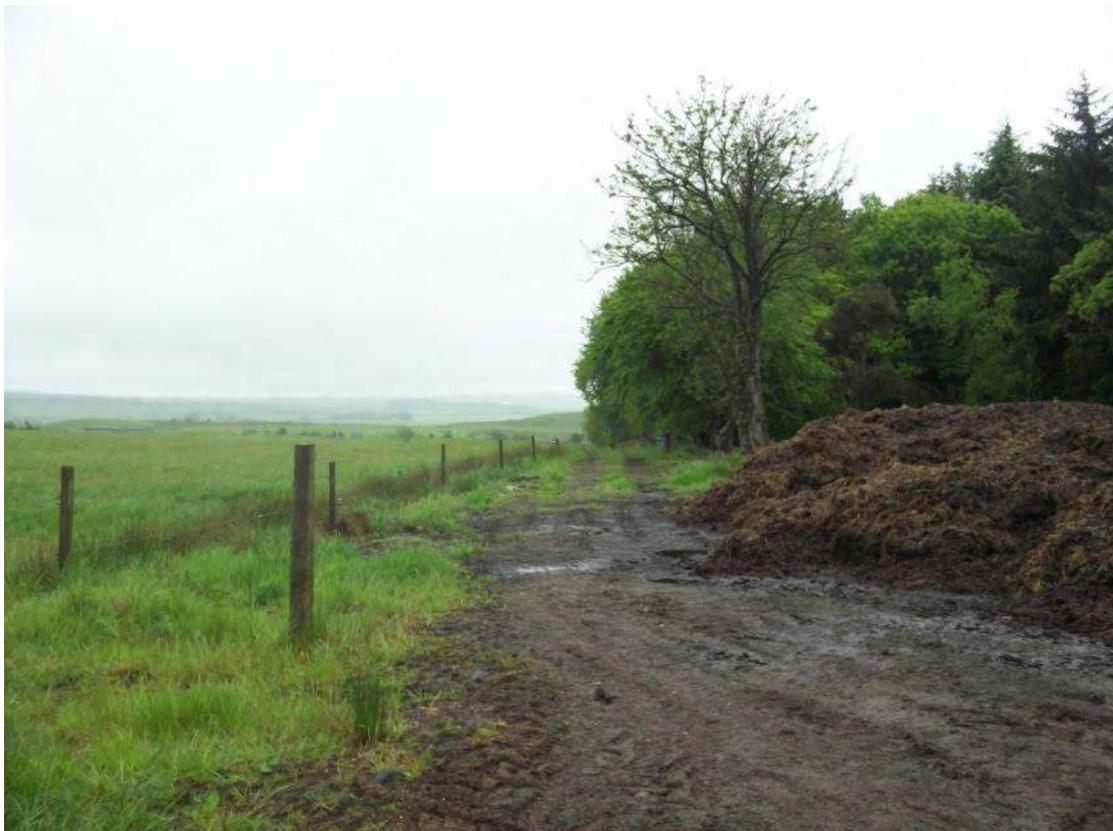
- The majority of the target site is used as grazing land for cattle. Piles of manure were noted to be stored at two locations across the site (within fields 24 and 25). These piles appear to consist of manure and bedding from winter cattle sheds.

Figure 22 – Pile of manure at the side of the track between fields 25 and 26.

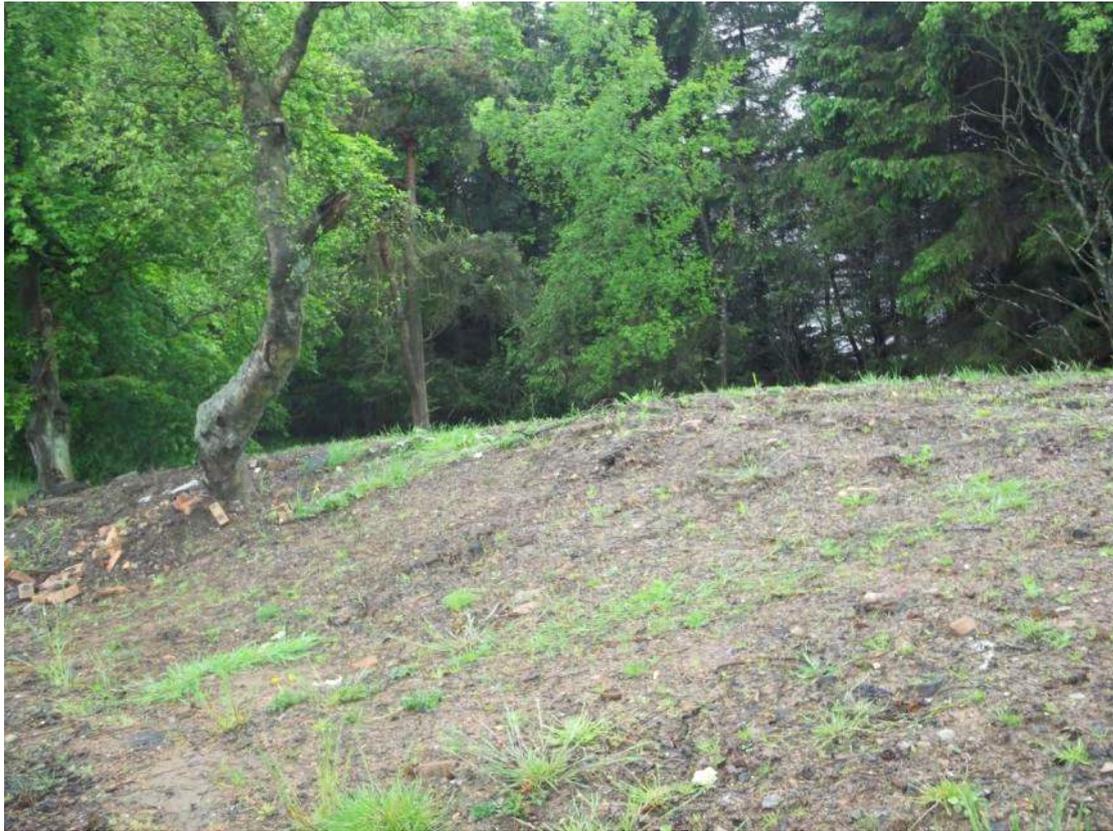
tarmac and concrete was also noted within field 24. Areas of levelled made ground were present along the eastern area of field 25 and part of field 22. This is presumed to be the footprint of the West Westertoun Farm buildings which are understood to have been located in this area.

Figure 23 – Area of made ground adjacent to pile of manure between fields 25 and 26.

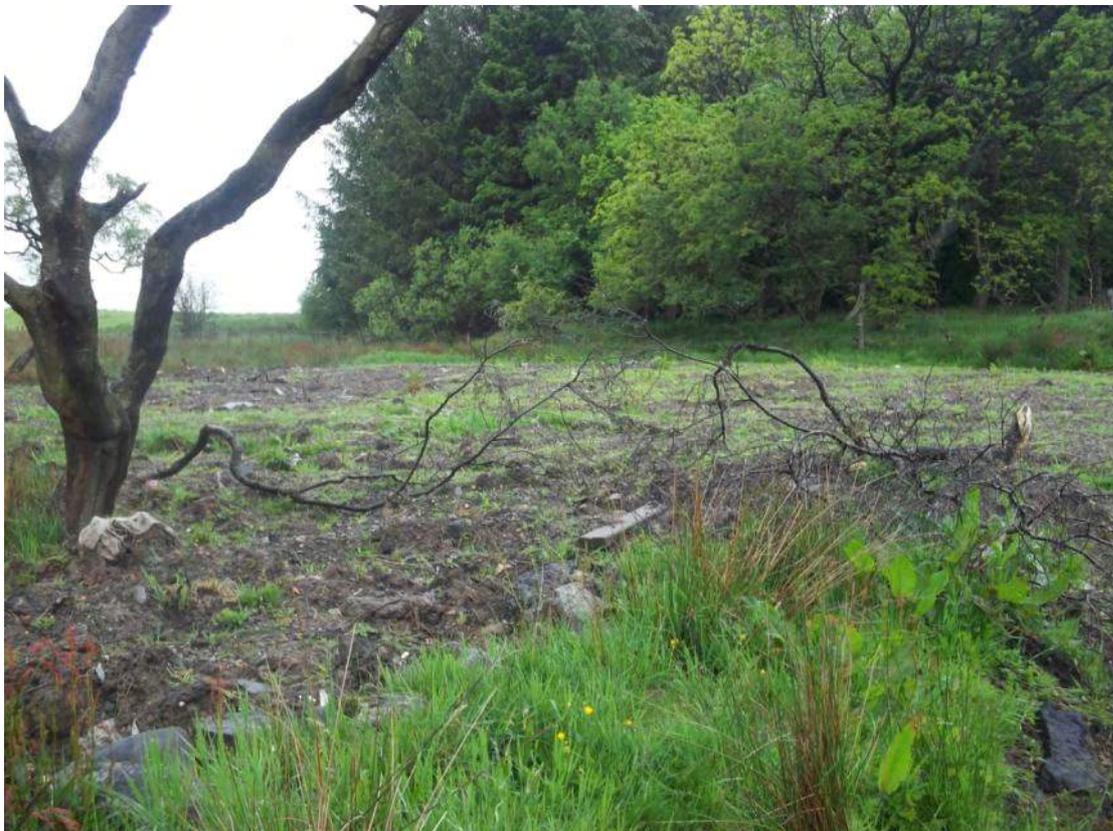
Areas of made ground presumed to be associated with West Westertoun Farm (which was demolished pre 1980) were observed on the east of Lot 3. Other small areas of construction debris of unknown provenance are present within field 24. These areas of made ground may present a source of contaminants. Potential contaminants could include asbestos, heavy metals, non-metals and hydrocarbons.

Figure 24 – Area of made ground between fields 25 and 26 at south of site.

Qualitative Risk ratings	Environmental Risks Low	Geotechnical Risks Low to Moderate (localised)
Recommendation(s)	<p>No further contaminated land assessment work is considered necessary for the future use of the site for woodland establishment.</p> <p>However if the Forestry Commission Scotland wishes to follow precautionary principle, consideration could be given to locating the mine entry indicated to be present on the south of the site by the Coal Authority to provide an assessment of ground stability risks in these areas and evaluate the suitability for these areas to be planted with trees and tracked with heavy vehicles. However as this potential mine entry represents an overall low proportion of the site, alternative consideration could be given to avoiding development of this area. Further consideration should also be given to avoiding areas of made ground, such as the site of former West Westertoun Farm or to assess the area for suitability for tree planting.</p>

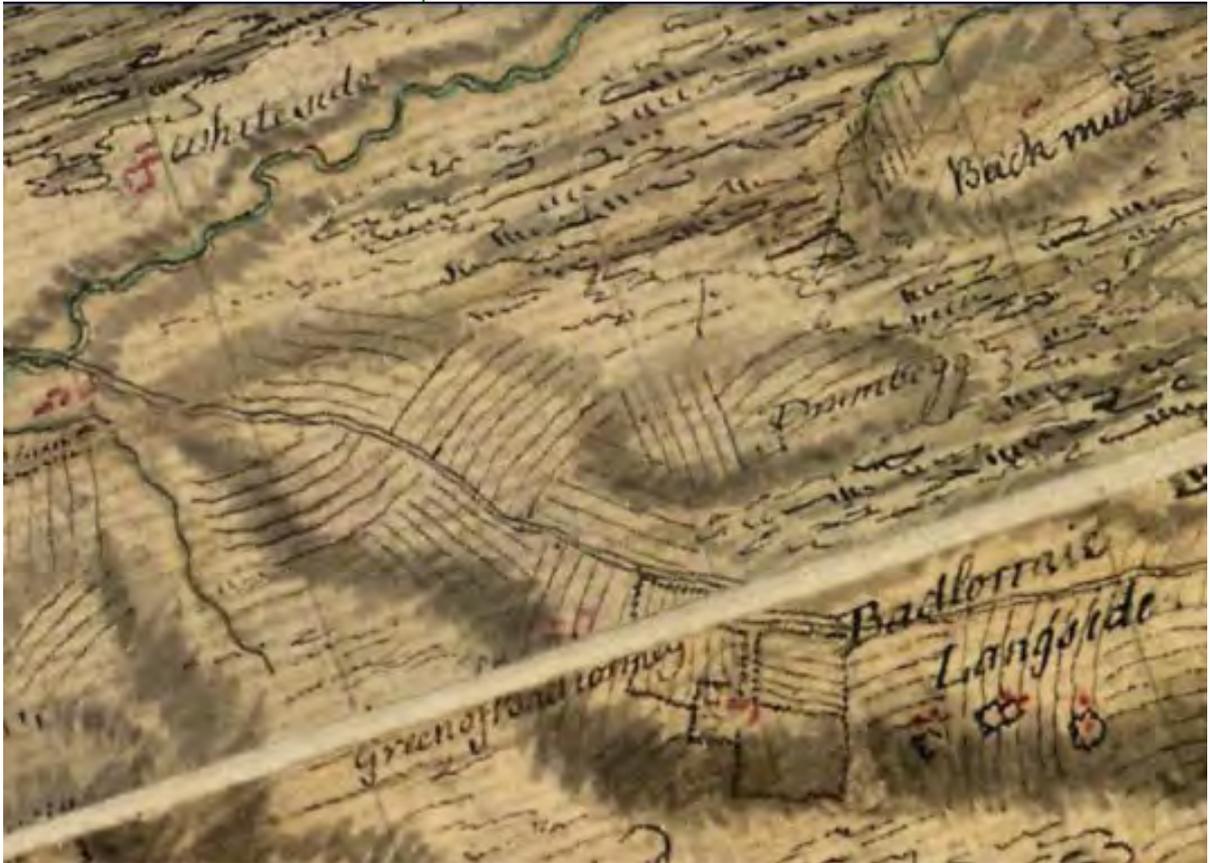
Figure 3a – Roy (1747-55)

The earliest sound mapping for the study area dates to the mid eighteenth century (Roy, 1747-55) and depicts a fairly high concentration of cultivation (rig & furrow) (Figure 3a), as well as a cluster of buildings (possibly named Green of Pond Lonney).

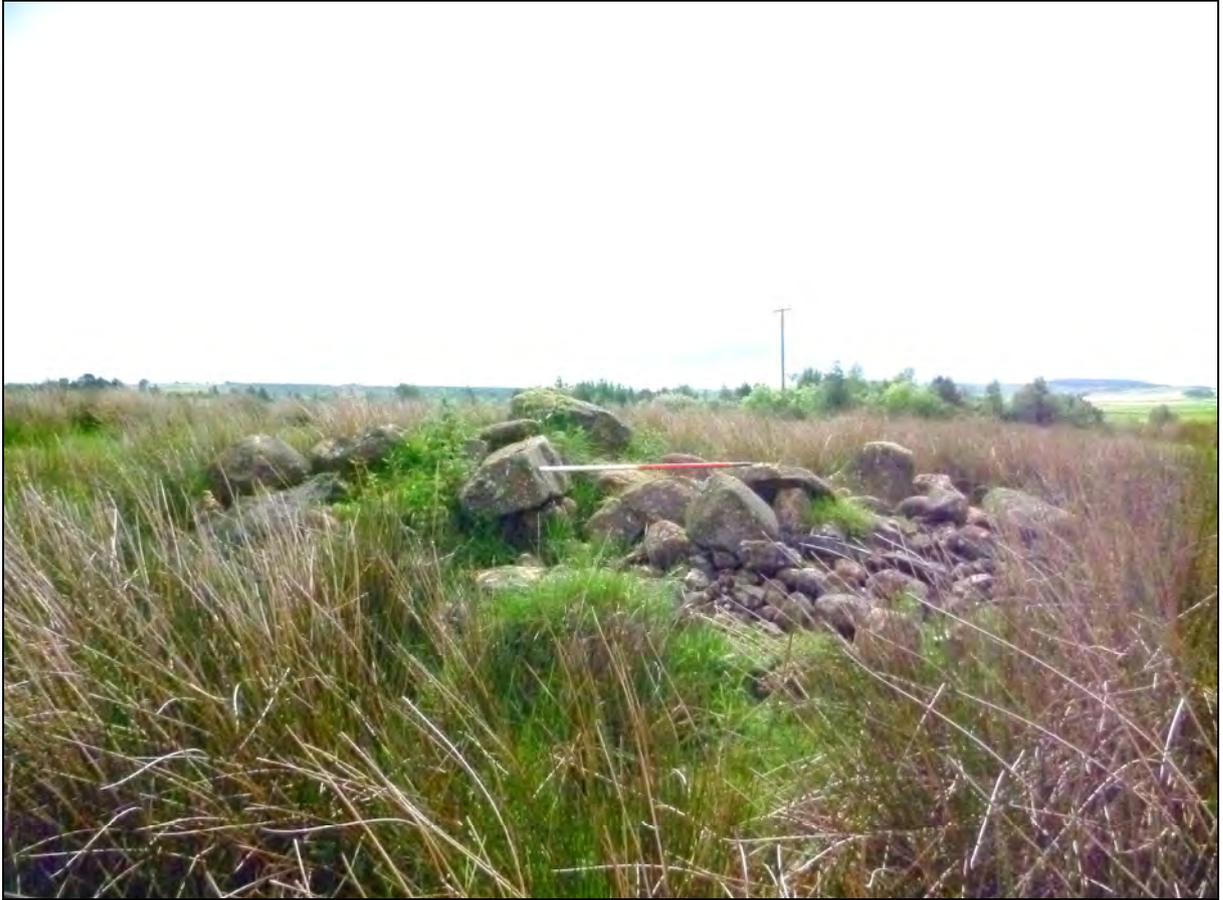
Figure 4a – clearance cairn (Site 3)

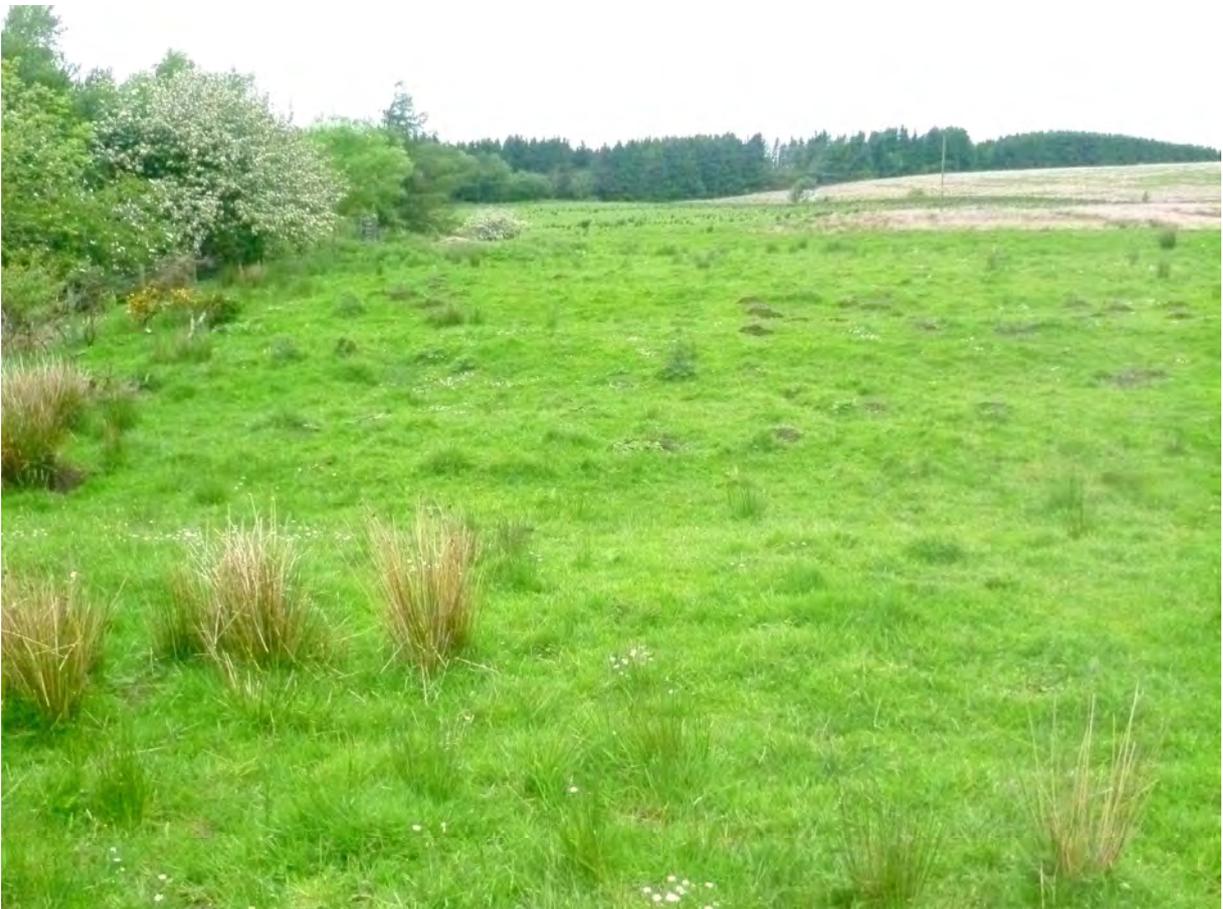
Figure 4b – area of rig & furrow (Site 4)

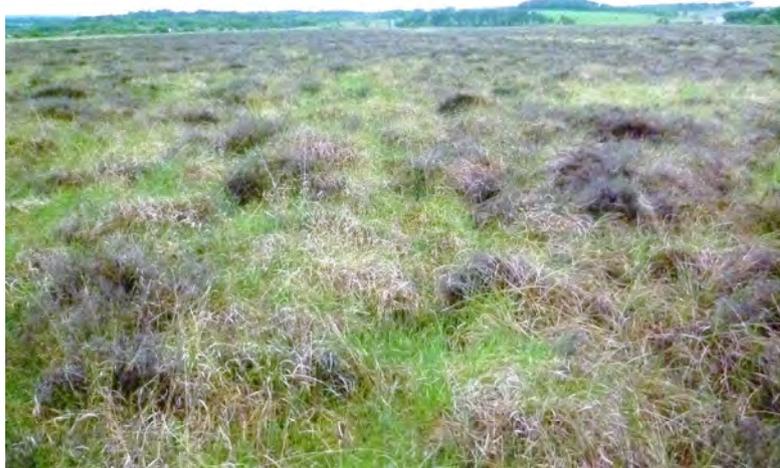
Figure 5a – showing rough (heather) ground along northern edge of site

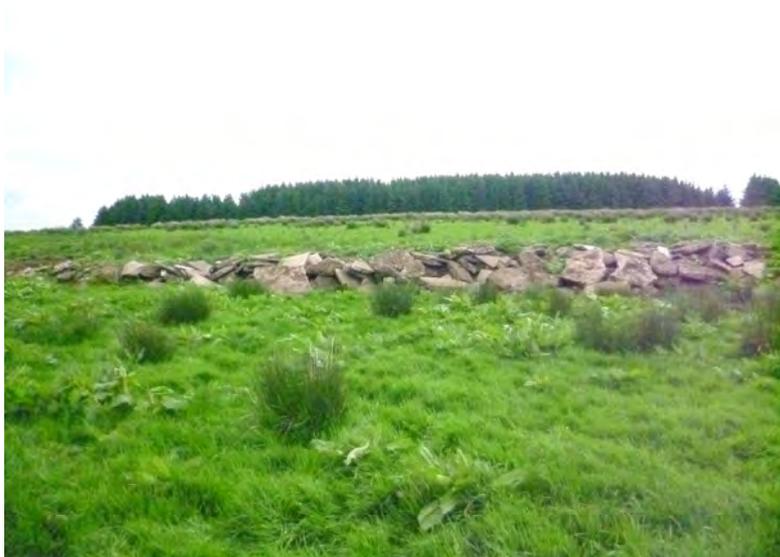
Figure 5c – demolition debris at edge of former opencast area (**Site 2**)

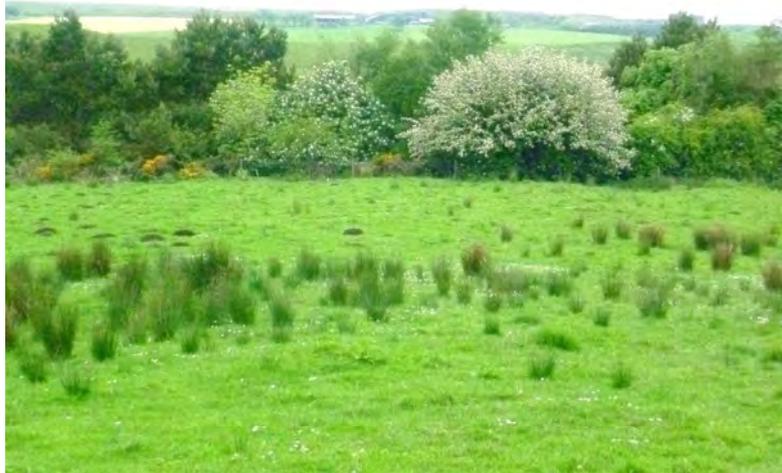
Figure 6a – area of rig & furrow (**Site 4**)

NO.	NGR / NMRS No. HER No.	Name	Class	Description
1	NS 8677 6761 NS86NE 29 Canmore ID 82840 WoSAS ID18405	Westertoun / Westertoun of Bedlormie	Building(s)	A group of buildings depicted on the 1st edition of the 6-inch OS map, about 800m WNW of Bedlormie (Linlithgowshire 1865, sheet viii), have been destroyed by opencast mining. (CSW 4376). Visited by RCAHMS (PJD) 9 September 1992. Westerton of Bedlormie Information from West Lothian Archaeology Group Entered WoSAS (MO'H) 31/03/2011.
2	Centred on NS 86488 67844	-	Demolition Debris (concrete/ tarmac)	Large area of (modern) demolition debris mainly comprising: concrete; concrete slabs and tarmac (Figure 5c) – possibly from a floor or area of hard-standing.
3	NS 86885 67218	-	Clearance Cairn	Oval cairn of various sized stones (some very large rocks) (Figure 4a), aligned E / W and measuring 7.5m by 4.5m (at most).
4	Centred on NS 86865 67146	-	Area of Rig & Furrow	Area of rig & furrow (Figures 4b & 6a). Rigs aligned NE / SW and measuring up to 3m in width (at most)

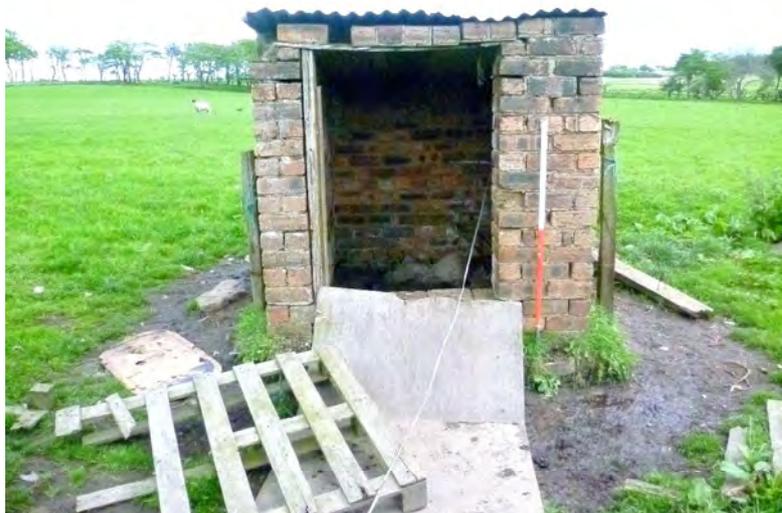
Figure 6c – small brick structure (watershed) (**Site 6**)

5	Centred on NS 86557 67295	-	Demolition Debris (bricks)	Area comprising a number of heaps of demolition debris – bricks visible in at least two heaps (Figure 6b). Brick mark – CAMPS.
6	NS 86067 67963	-	Very small red brick structure	Very small red brick structure with an entrance in the W wall (Figure 6c) and a small opening at the base of the N wall. Structure appears to be no longer in use. Water pump house.
7	NS 8720 6739 NS86NE 4 Canmore ID 46717 WoSAS ID 17762	Bedlormie Wood / St Johns Well	Well	St John's Well is a very fine spring of pure cold water. It is enclosed with rough stone work and is never dry. It is not known how it obtained its name, nor is there any tradition in the neighbourhood regarding it. Name Book 1856. A stone-lined well with no

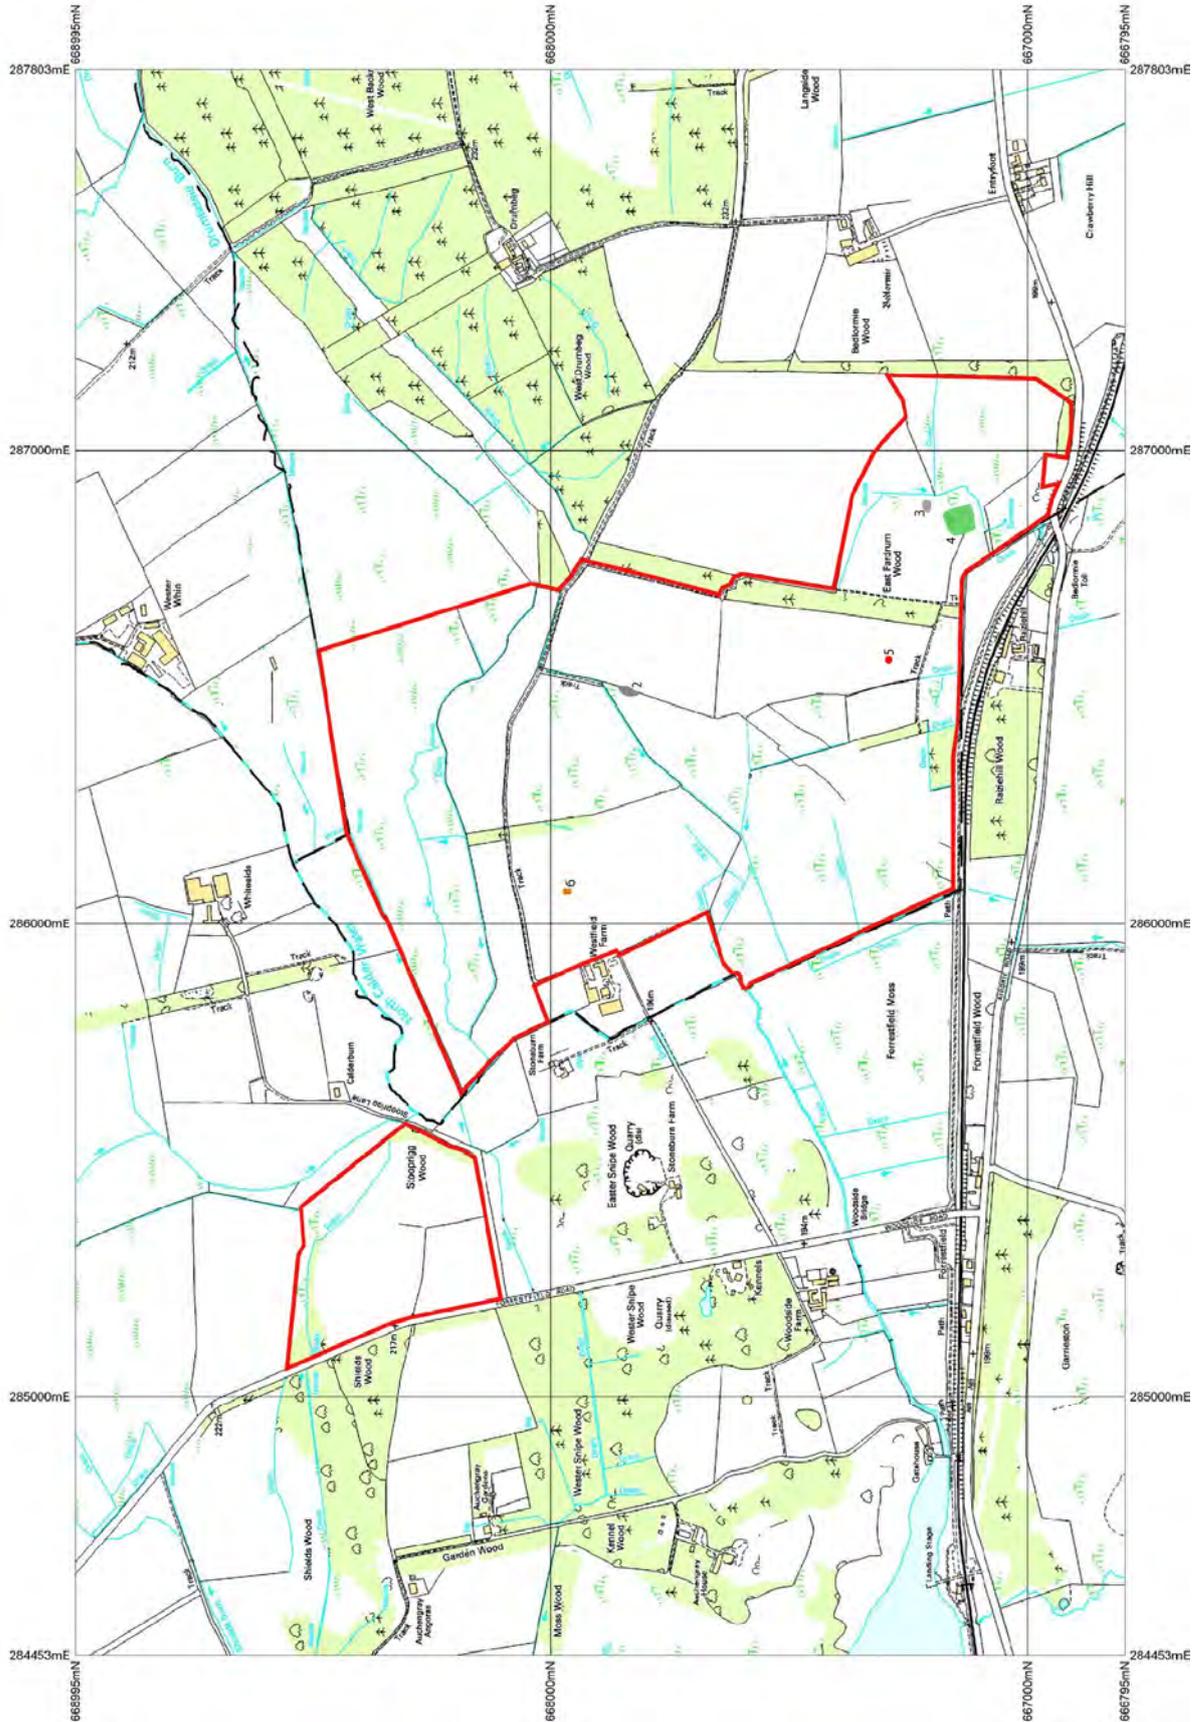
Site No	Site Type	Site Name	Importance	Significance
1	Farmstead	Westertoun	Local	-
2	Spoil heap (demolition debris)	-	Local	Low
3	Clearance cairn	-	Local	Moderate
4	Cultivation remains (rig & furrow)	-	Local	Moderate
5	Spoil heap (demolition debris)	-	Local	Low
6	Structure	-	Local	Low

Figure 7 – site map indicating sites / areas of archaeological interest

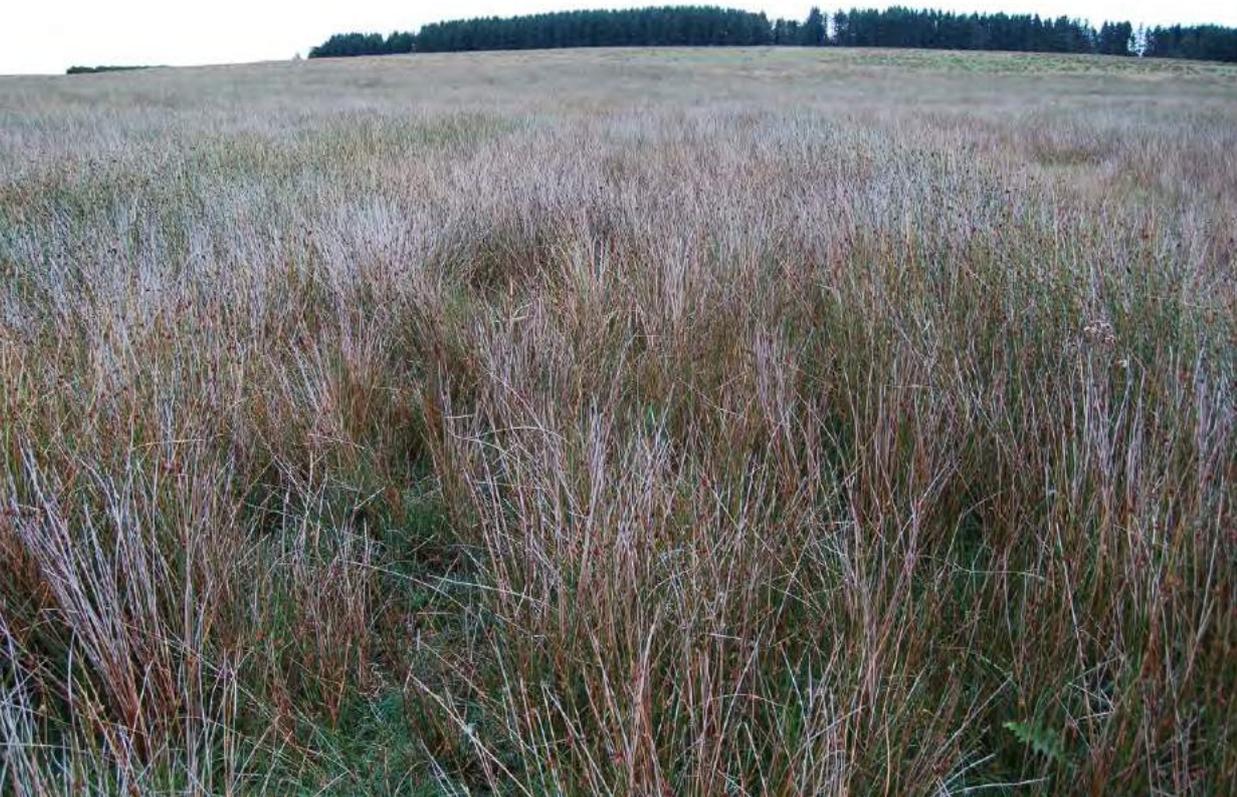
Species poor MG10 dominated by Soft-rush, most of the neutral grassland present on site looks like this.

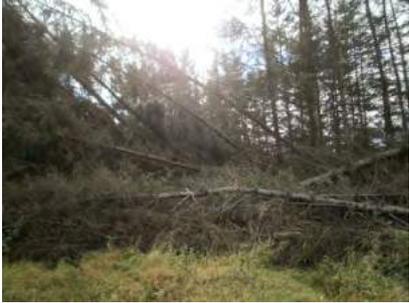
Feature	Target Notes	Description	Photograph
Habitats			
Conifer Plantation (A1.2.2)	13	<p>Conifer plantation consisted of a narrow strip of conifers along the eastern boundary of the site. This was fairly open in nature with the entire middle section consisting of windblow. Provides suitable habitat for common species such as siskin and woodpigeon.</p> <p>A second area of young conifers was located to the north of the farm track at NS867 679. This area provides suitable nesting habitat for small songbirds such as mistle thrush <i>Turdus viscivorus</i> and willow warbler <i>Phylloscopus trochilus</i>.</p>

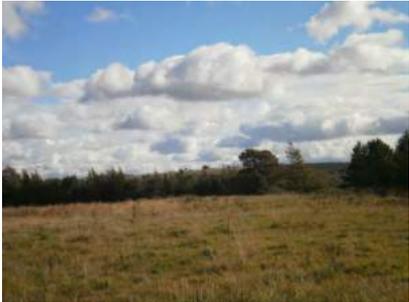
Mixed Plantation (A1.3.2)	15	<p>There is an area of mixed plantation located on raised bog at NS868 670. This provides suitable nesting habitat for a wide range of bird species. A second area of mixed plantation is located in the north-eastern corner of the site at NS869 669.</p> <p>A third area of mixed plantation consisting of pine, beech and sycamore <i>Acer pseudoplatanus</i> located on the eastern edge of the improved pasture at NS854 684.</p>

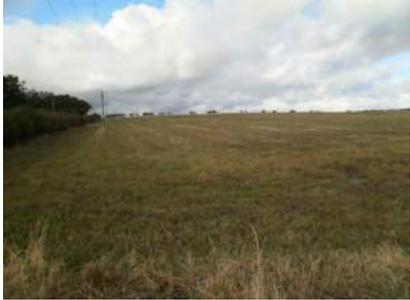
Improved Pasture (B4)	17	Improved pasture at the site consists of a large field (with a defunct hawthorn <i>Crataegus monogyna</i> hedge running up the centre). This is located at the north-western part of the site (NS854 682).

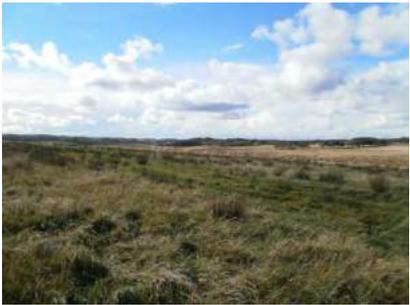
Marshy Grassland (B5)	3, 12, 14	NS859 680. Along with raised bog, marshy grassland is the dominant habitat at the site. This habitat is suitable for upland nesting birds, particularly snipe and meadow pipit.

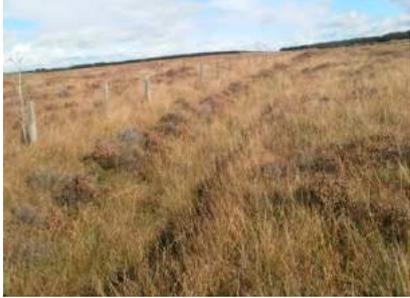
Raised Bog (E1.2)	7, 8, 15	NS859 682. On the northern side of the farm track leading east from Stoneburn Farm the habitat is dominated by raised bog. This bog shows signs of modification illustrated by drainage ditches around the outside of the bog. The bog provides good nesting habitat for upland bird species.

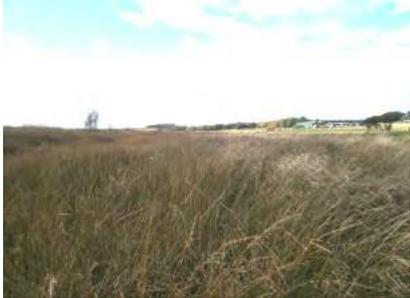
Wet Flush (E2)	9	NS857 682. On the north edge of the bog in the northern part of the site is a small area of wet flush separating the bog from the southern bank of the North Calder Water. This provides good nesting habitat for snipe and reed bunting <i>Emberiza schoeniclus</i> , however it is just outside the site boundary.

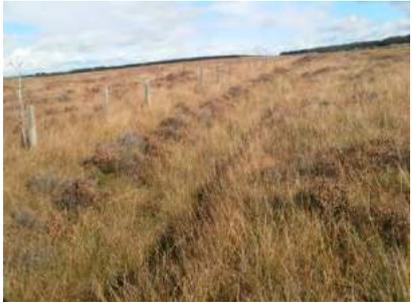
Brown Hare	8	<p>During the survey a brown hare was seen on the raised bog at NS86538 68144.</p>
