Leadburn Woodland Peatland Assessment

Compiled by Alistair McDonald

Tweed Forum

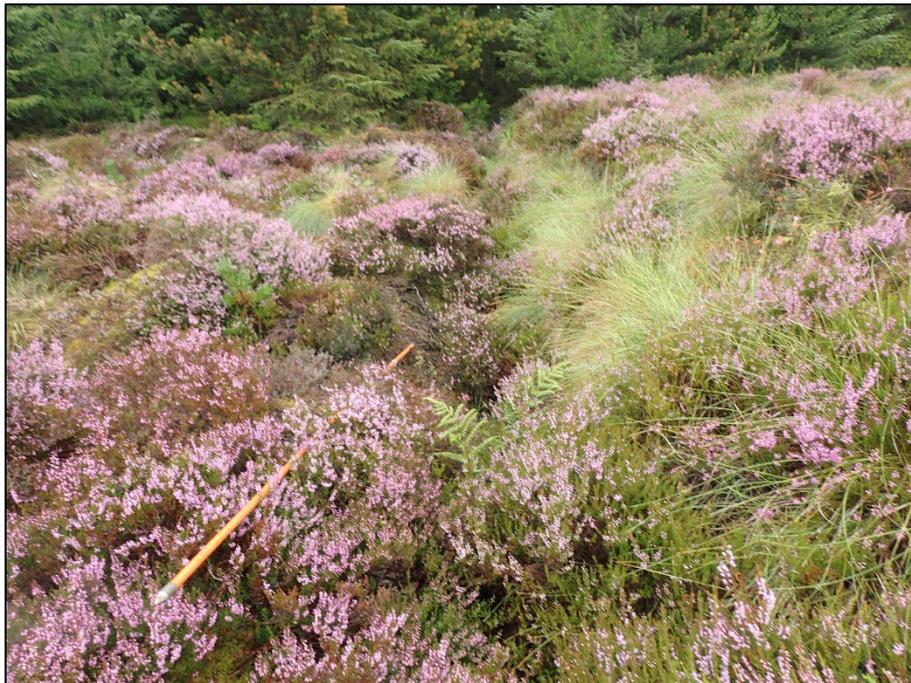
The survey revealed a maximum peat depth of 630cm and an average across the site of 365cm. Windblown trees are extensive throughout the site and made access difficult in places. There are a number of drains which pass through the site (Figure 2). These vary in depth and some appear to have been blocked using plastic piling (Figure 3). The majority of planting has been done using furrows which vary between 20 and 60cm in height. Alongside the drains these are decreasing the site's water retention capability. The results of the survey are shown below in Figures 4 and 5.

Figure 2: Drain cutting through the site. Although not wide the majority of drains are over 50cm deep.

Alongside this, ditch blocking would need to be carried out using either plastic piling or peat dams as the drains are too wide and deep to be blocked by brash. In order to qualify for Peatland Action funding both ditch blocking and mulching would need to be carried out simultaneously as ditch blocking is not eligible as a standalone item.

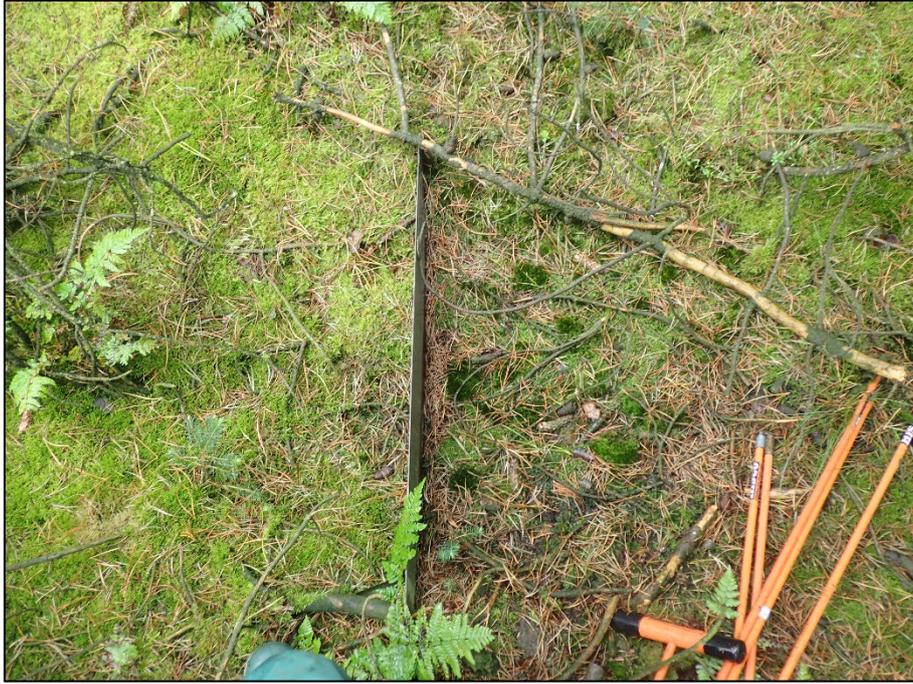
Figure 3: Plastic piling successfully blocking a ditch on site and encouraging sphagnum regeneration.

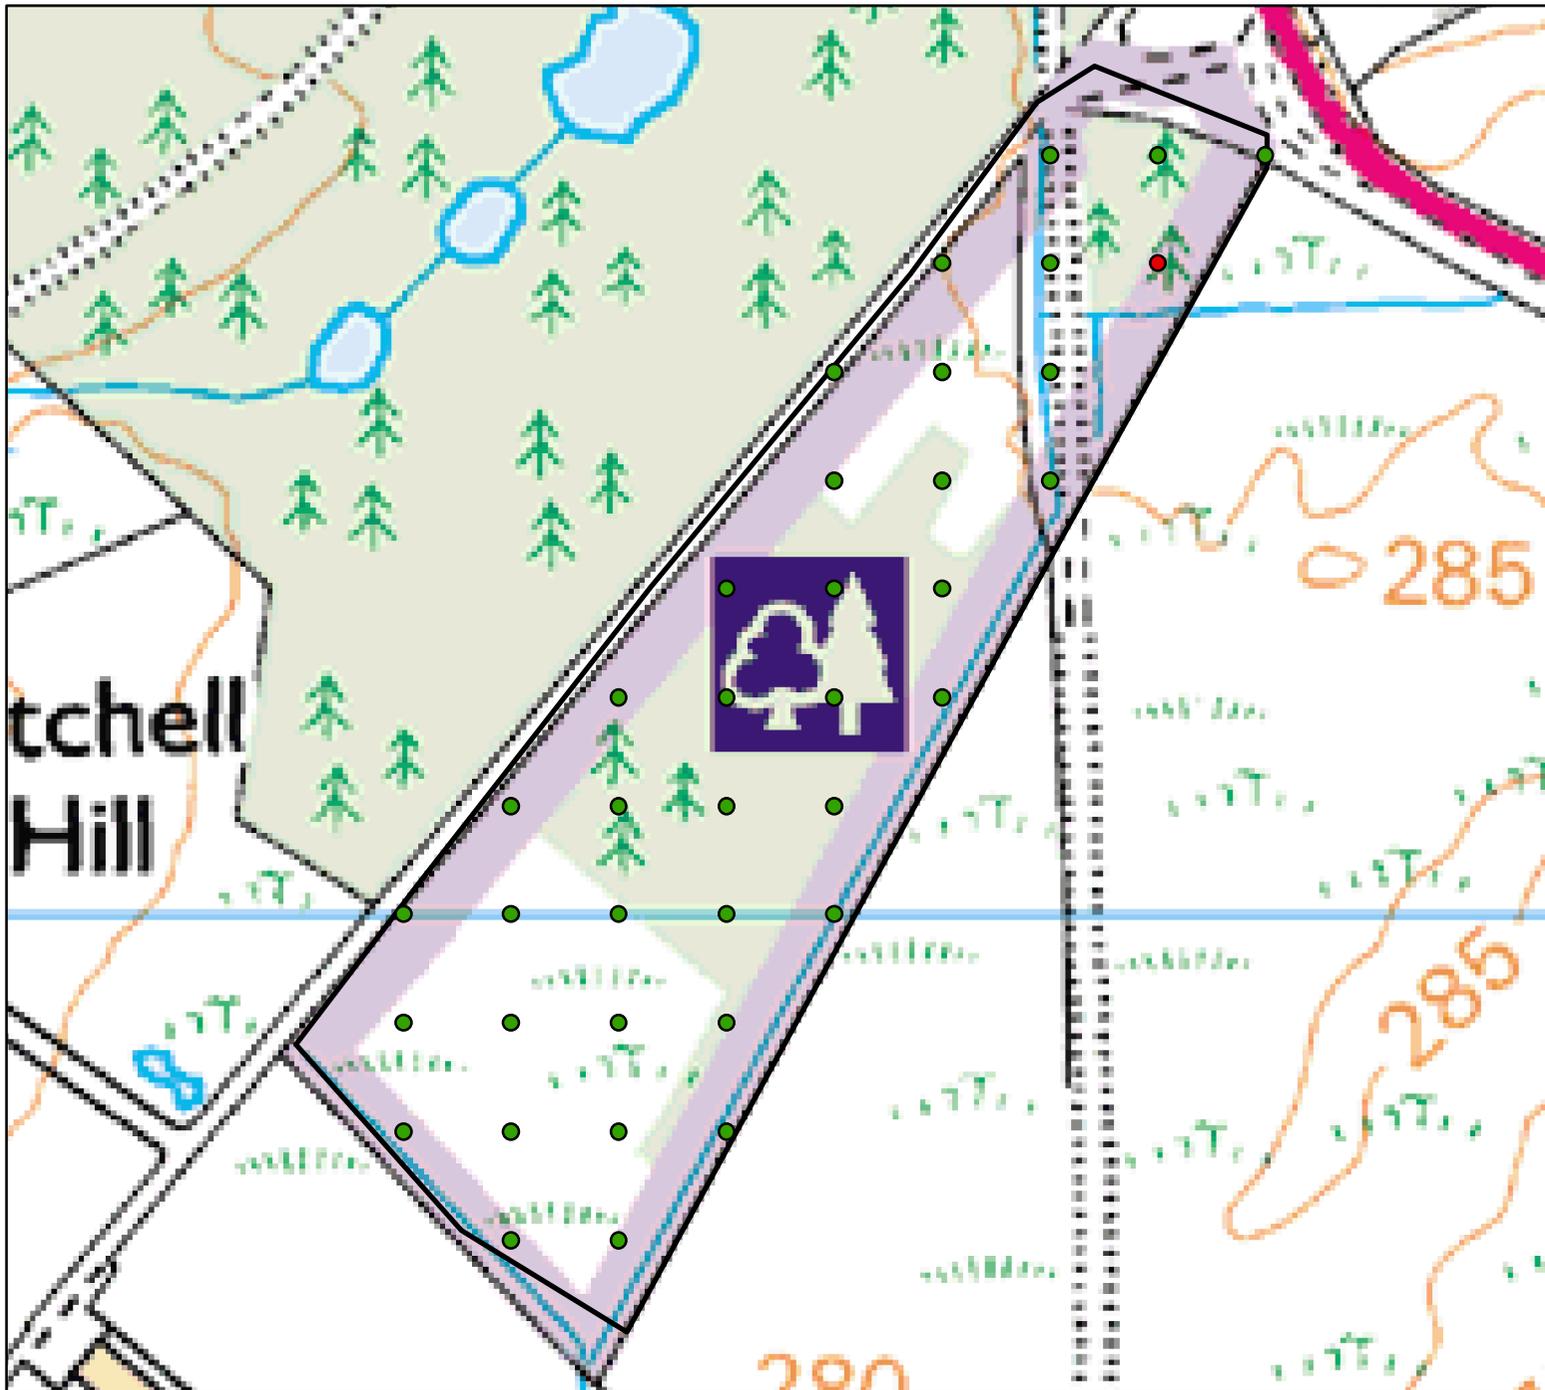
Leadburn Woodland Peat Depth

A peat depth survey was carried out over a 9ha area within the conifer block. Measurements were taken every 50m to give a more accurate understanding of the peat's profile. 38 separate sites were measured using an industry standard peat probe and recorded on a Garmin GPS with a precision of $\pm 5m$. One site could not be reached due to windblow and was estimated based on the surrounding measurements. Geo-referenced photographs were taken to give an overview of the site's vegetation and hydrological condition.

Figure 4: Survey sites at 50m spacing

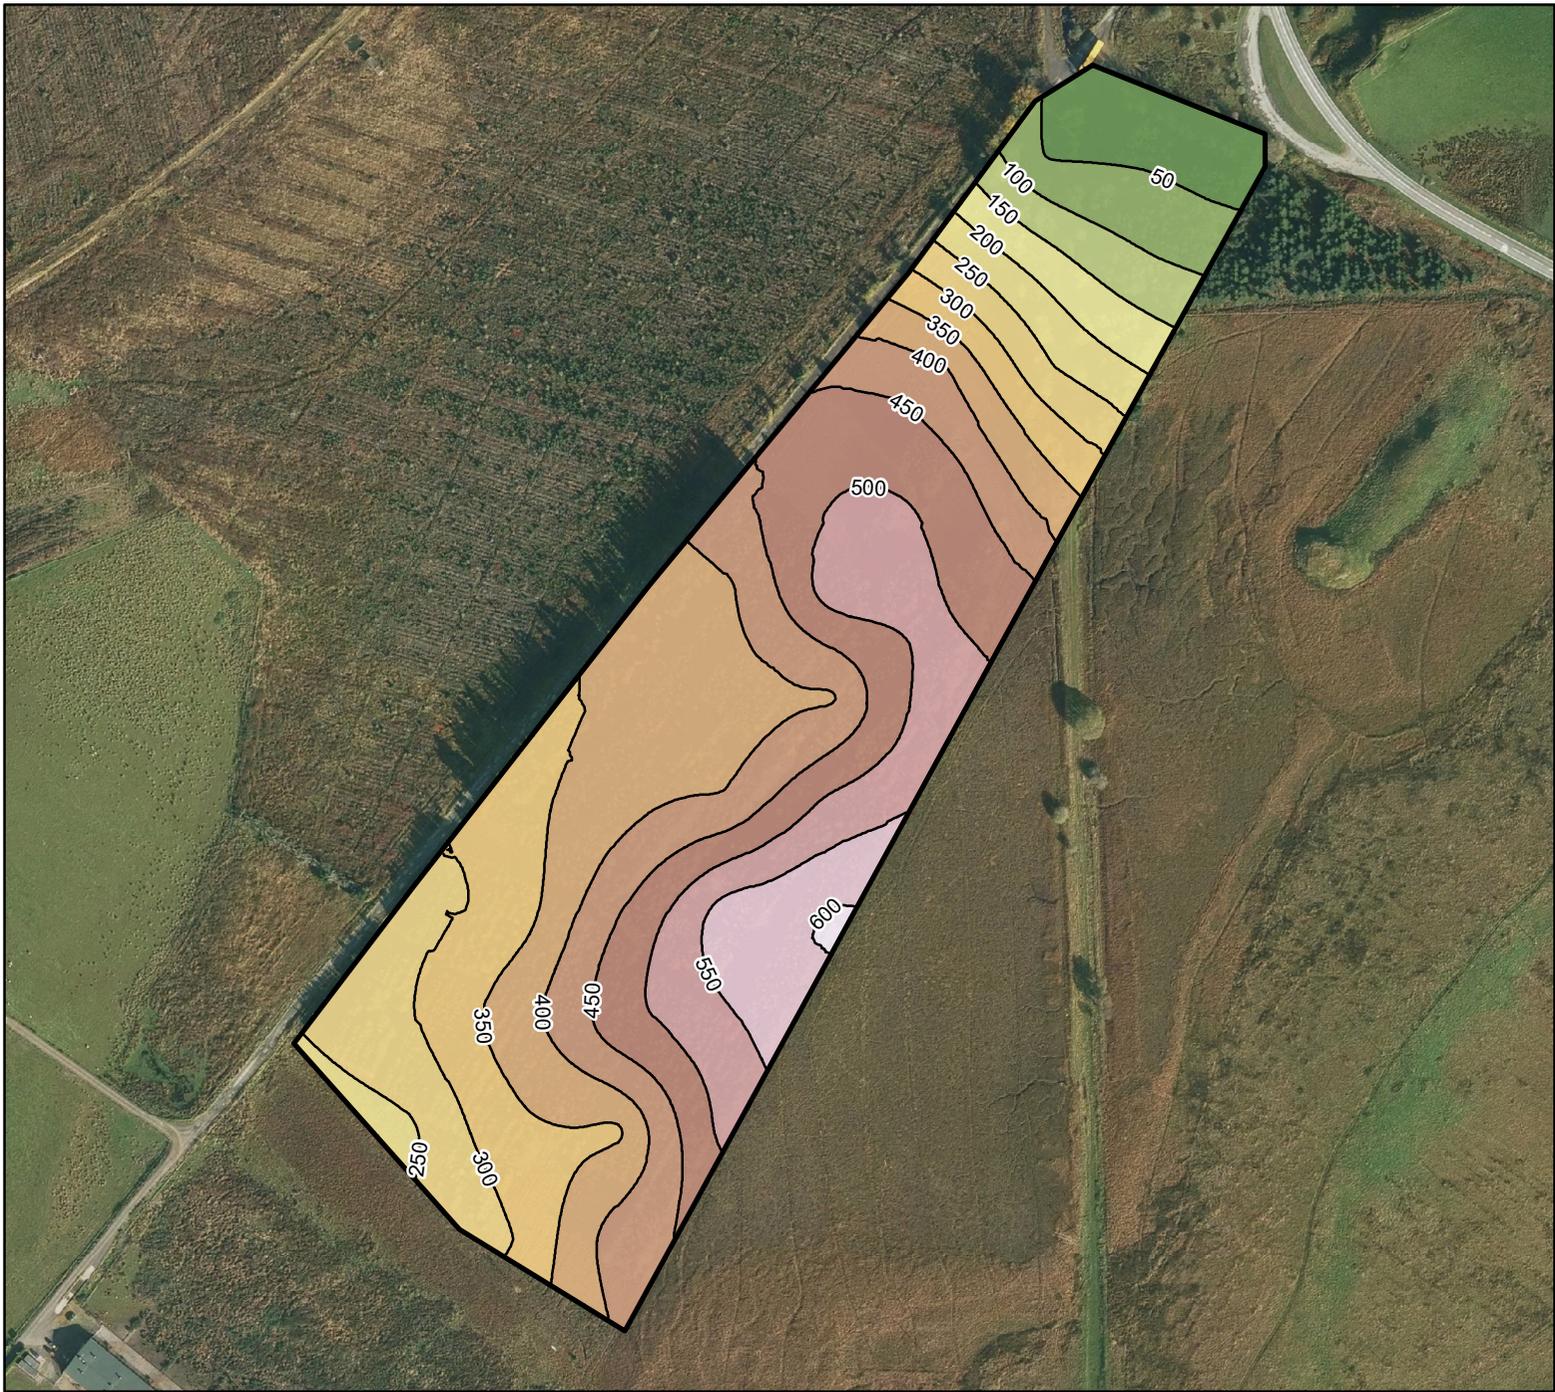
Leadburn Woodland Peat Depth

Figure 5: Estimated peat depth based on measurements taken at each survey site.

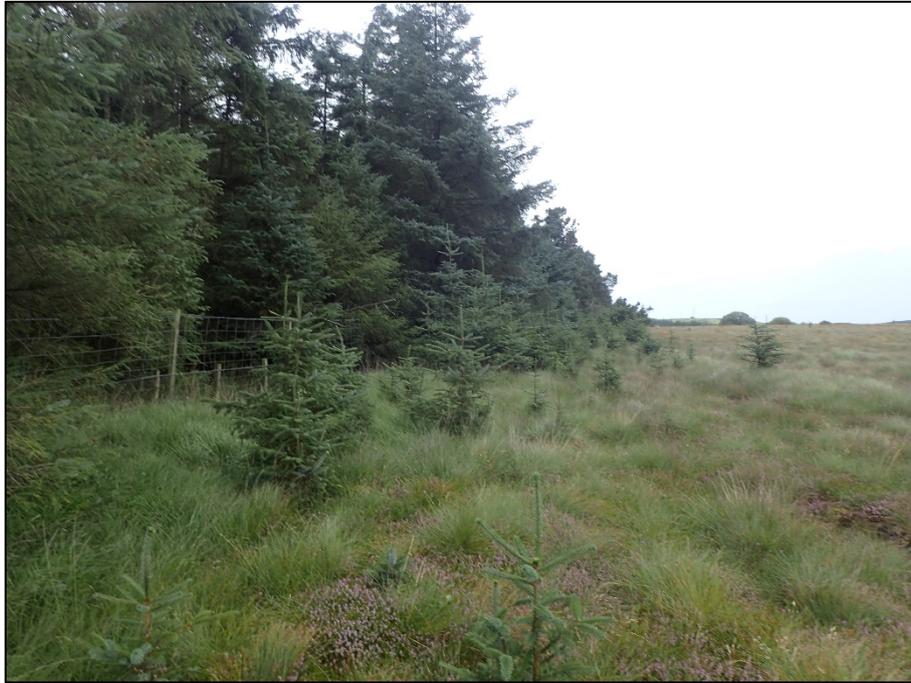
The report by Anderson (2013) clearly demonstrates the rich botanical biodiversity present on the site in areas that have not been planted. This suggests that with appropriate restoration techniques the site could be returned to a lowland raised bog habitat. Any restoration carried out should focus on raising the water table and eliminating conifer regeneration (Figure 6).

Figure 6: Sitka regeneration along the eastern boundary. Regeneration must be managed post restoration to ensure that the water table remains high enough to support a raised bog habitat.

If successful in applying for a Peatland Action grant the owner must agree to maintain the site in its restored state for 10 years. This would entail controlling conifer regeneration over this timescale. If the wood is to be felled commercially it should be noted that Peatland Action funding cannot be used to aid extraction.

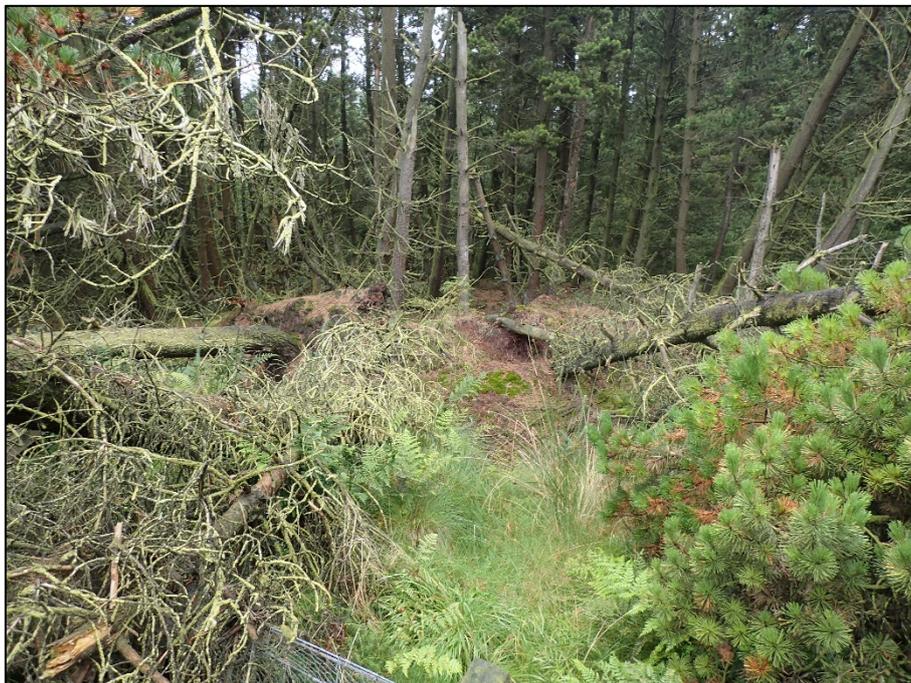
Figure 7: Areas of windblown trees are prevalent throughout the site.

Ideally, mulching should be carried out across the site to prevent any unnecessary sources of conifer regeneration and provide a smooth surface for bog plants to take hold. There is a danger that leaving trees to fell naturally by wind will leave a scene similar to Figure 7 in which the surface is severely distorted and the water table reduced. Mulching, in essence, is an attempt to speed up the natural process of decay whilst using the tree matter as an agent to block the furrows and raise the water table.
