Flanders Moss peatland restoration

Hydrological impact assessment

Forestry and Land Scotland

Detailed report

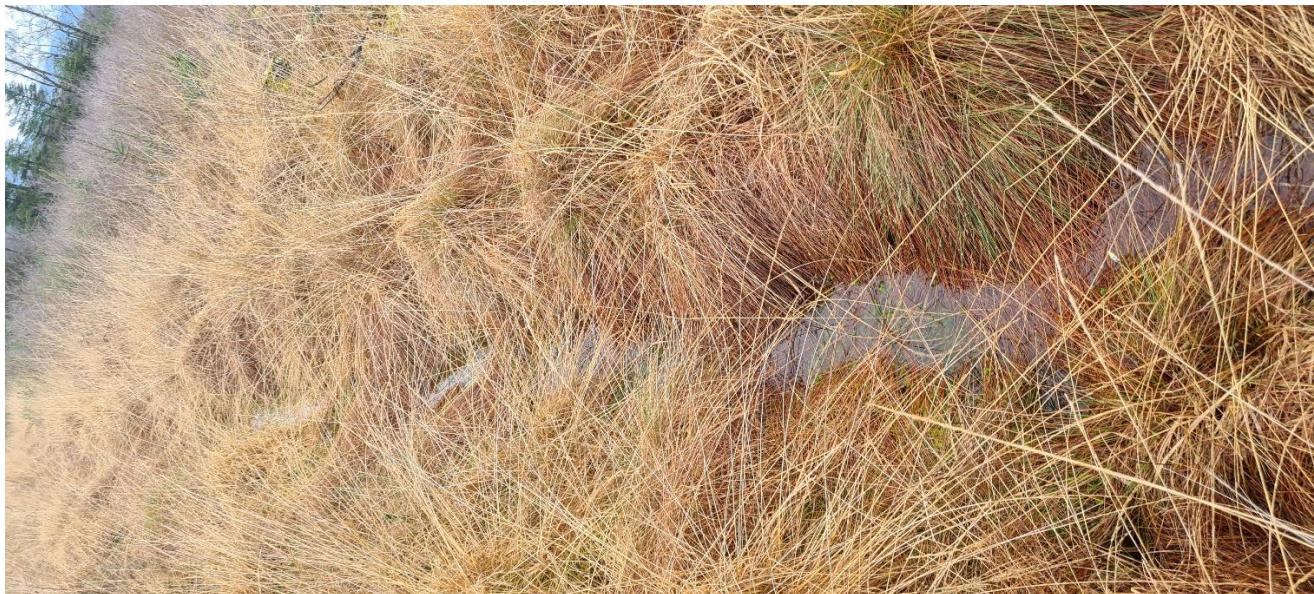
Figure 2-6 - Easterhill - saturated ground (Photograph 1)

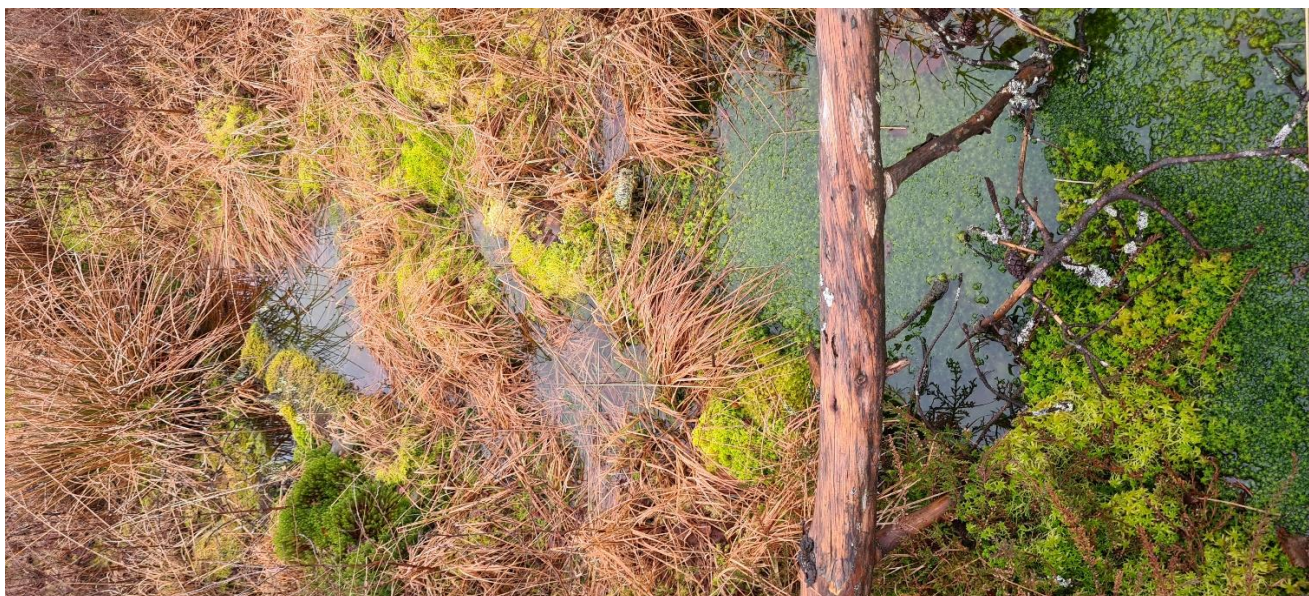
Figure 2-7 - Easterhill – Naturally infilling drainage ditches and sphagnum growth (Photograph 2)

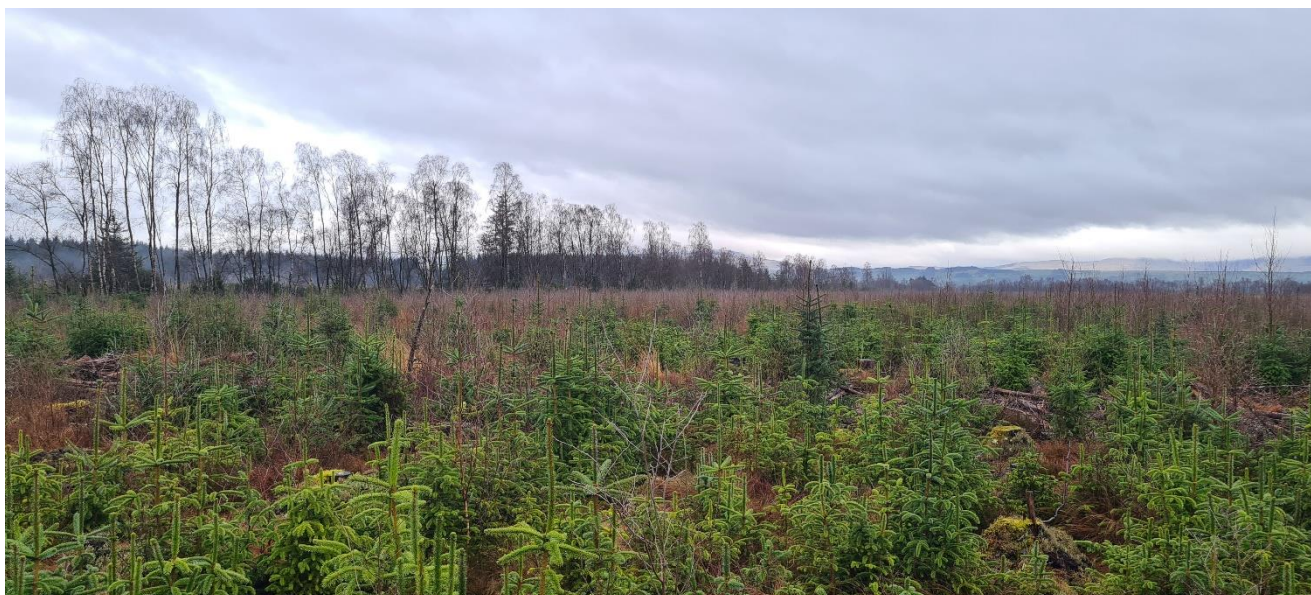
Figure 2-8 - Easterhill – Regeneration (Photograph 3)

Much of this block had some degree of tree regeneration, as can be seen in Figure 2-8, although there were some areas where it was likely too wet for regeneration to occur, particularly in the middle of the western half of the site.

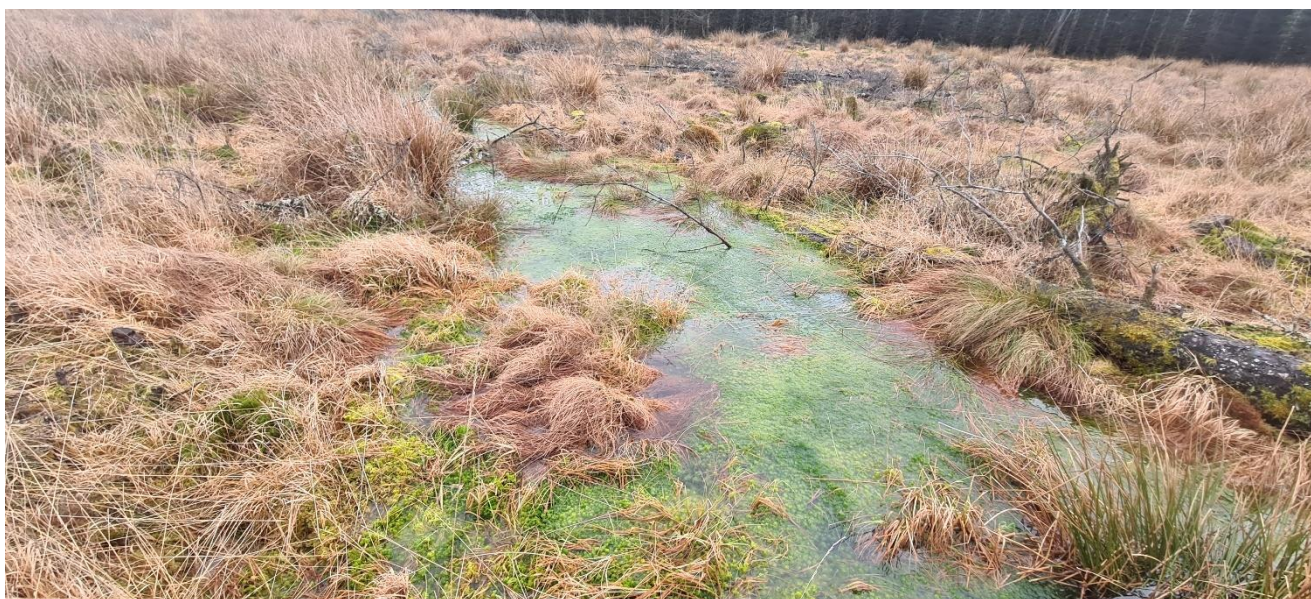
Figure 2-10 - Gartrenich - Ground conditions (Photograph 4)

Due to the very wet ground conditions (Figure 2-10), traversing the site was extremely difficult and it was not possible to walk through the wooded areas. However, observations from the edge of the south side woodland near the centre of the site confirmed these areas to also be saturated (Figure 2-11). FLS staff indicated that these trees have not been felled at present due to the ground being too wet for machinery access. Additionally, the trees appeared to have been heavily affected by the saturated ground as they were not growing healthily.

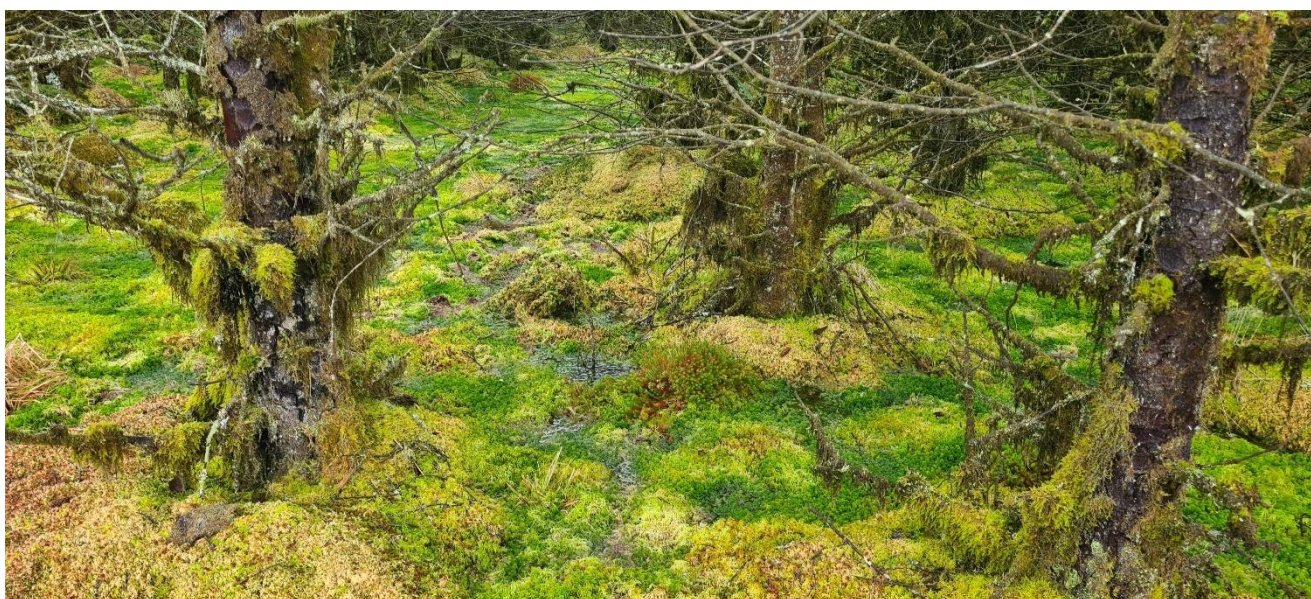
Figure 2-11 - Gartrenich - Saturated woodland (Photograph 5)

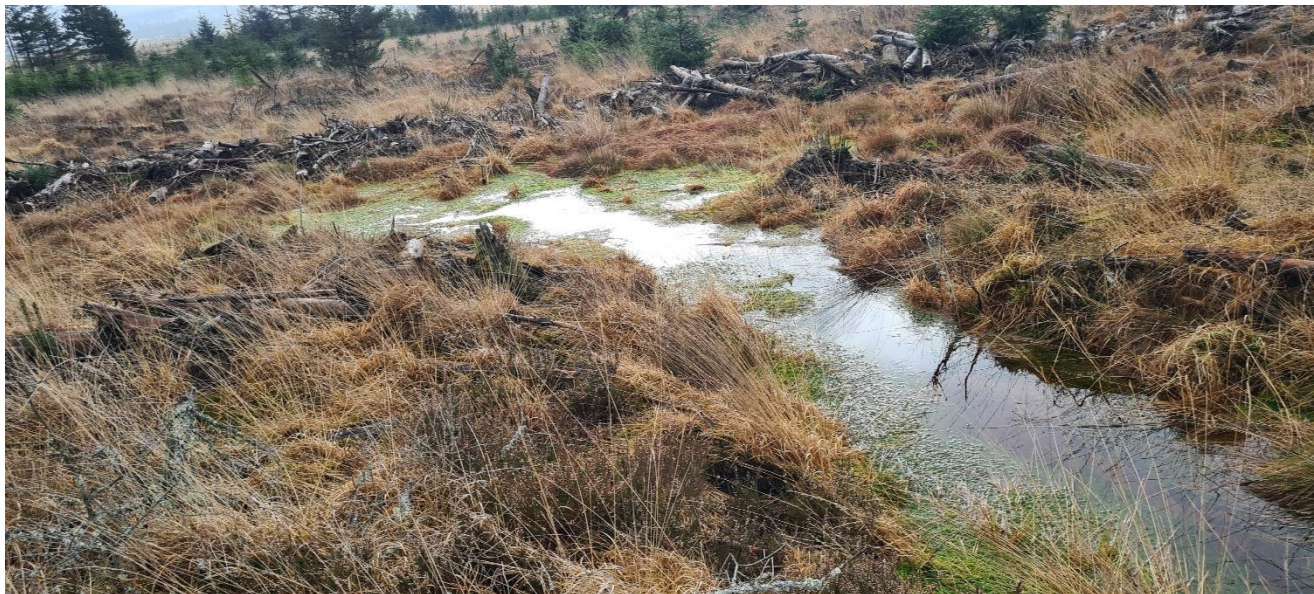
Figure 2-13 - Flanders Moss (North) – Drainage (Photograph 6)

The northern section of Flanders Moss was found to be considerably dryer than Gartrenich Moss and Easterhill. The drainage ditches across the site were much more pronounced and there was a notable throughflow of peaty water (Figure 2-13). There has been considerable tree regrowth in many areas of this block, although this was more evident towards the south of the area walked (Figure 2-14).

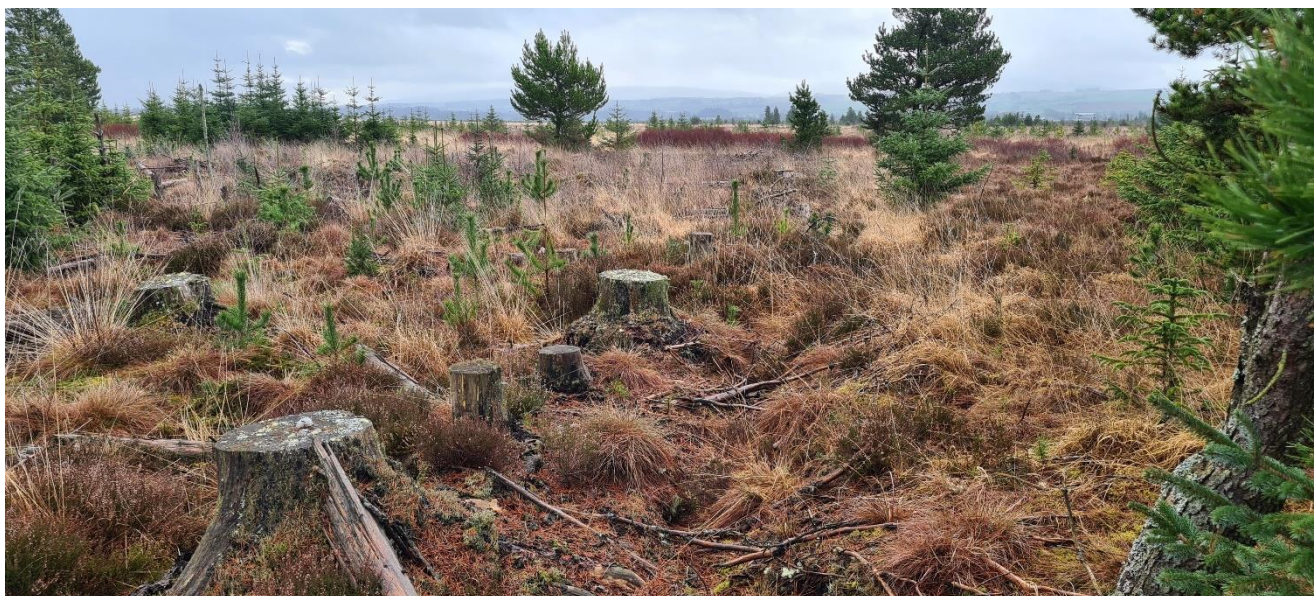
Figure 2-14 - Flanders Moss (North) – Regeneration (Photograph 7)

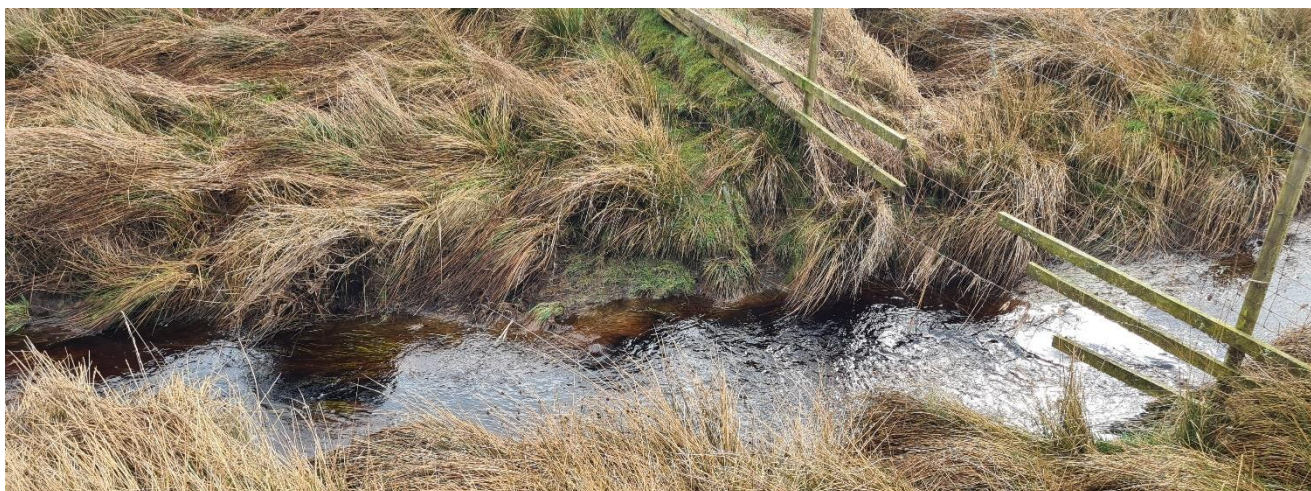
Figure 2-15 - Flanders Moss (North) - Watercourse (Photograph 8)

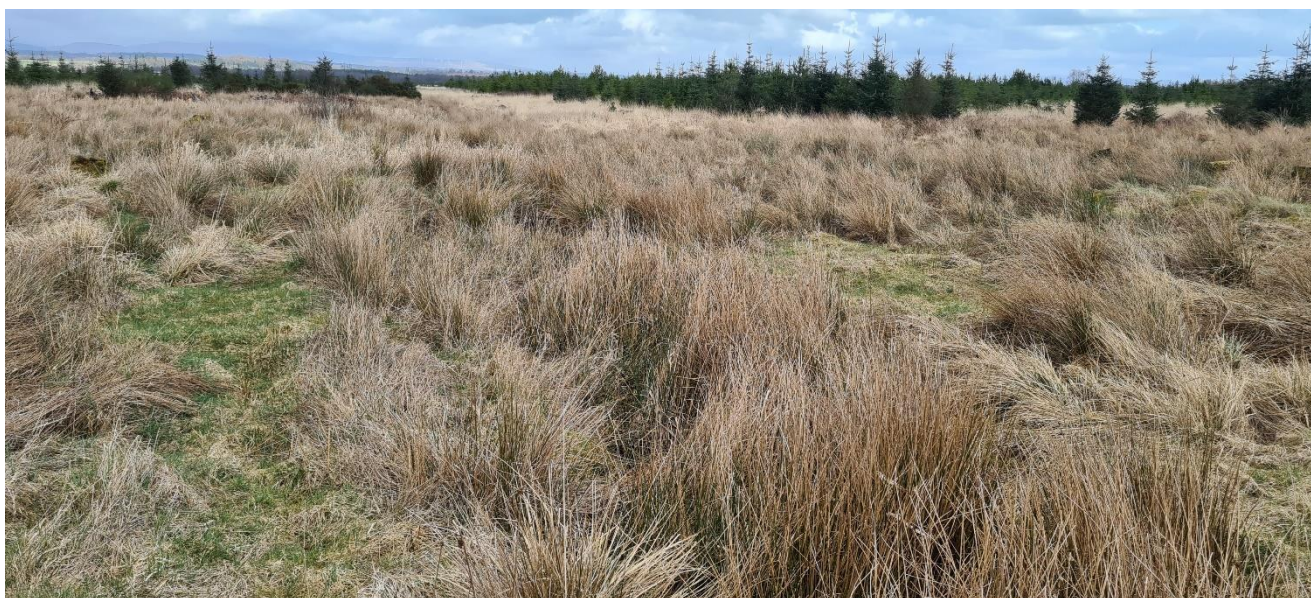
Figure 2-16 - Flanders Moss South - General ground cover (Photograph 9)

The site to the south of Flanders Moss was largely very dry and grassy (Figure 2-16) with some locally very wet areas. The locally wet area may possibly be attributed to the distance to the larger drains on the site. Many of the drains appeared to be naturally infilling with vegetation and old organic matter. Little to no throughflow was perceived in the naturally infilling drains, whereas the more open drains have substantial flow. There are many areas of exposed, degraded peat noted to the south of Flanders Moss (Figure 2-17). Many of these relate to the large drain to the southeast of the block (Figure 2-18), which looks to be entirely man-made and is having a substantial draining effect on the land adjacent to it. This large drain is not shown on the drainage maps provided by FLS but is within 30m of the FLS boundary, therefore it is assumed that it is to be retained. Peat pipes with flowing water were noted intersecting this drain and hence the effect in terms of drying likely extends well away from the drain.

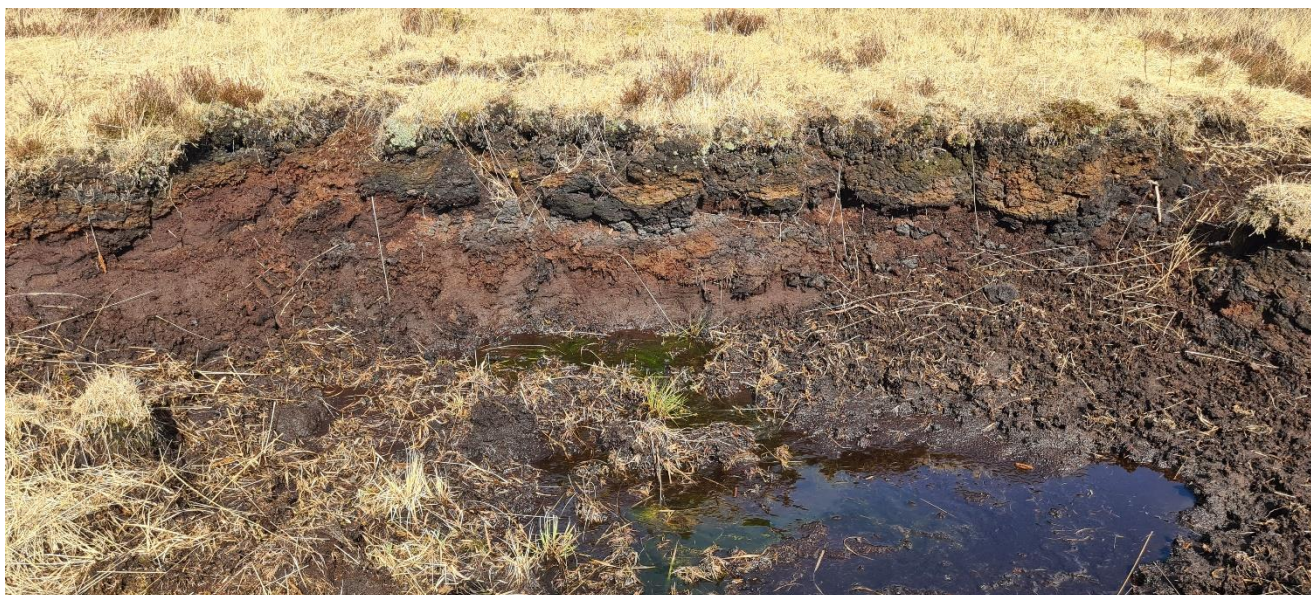
Figure 2-17 - Flanders Moss South - Exposed peat (Photograph 10)

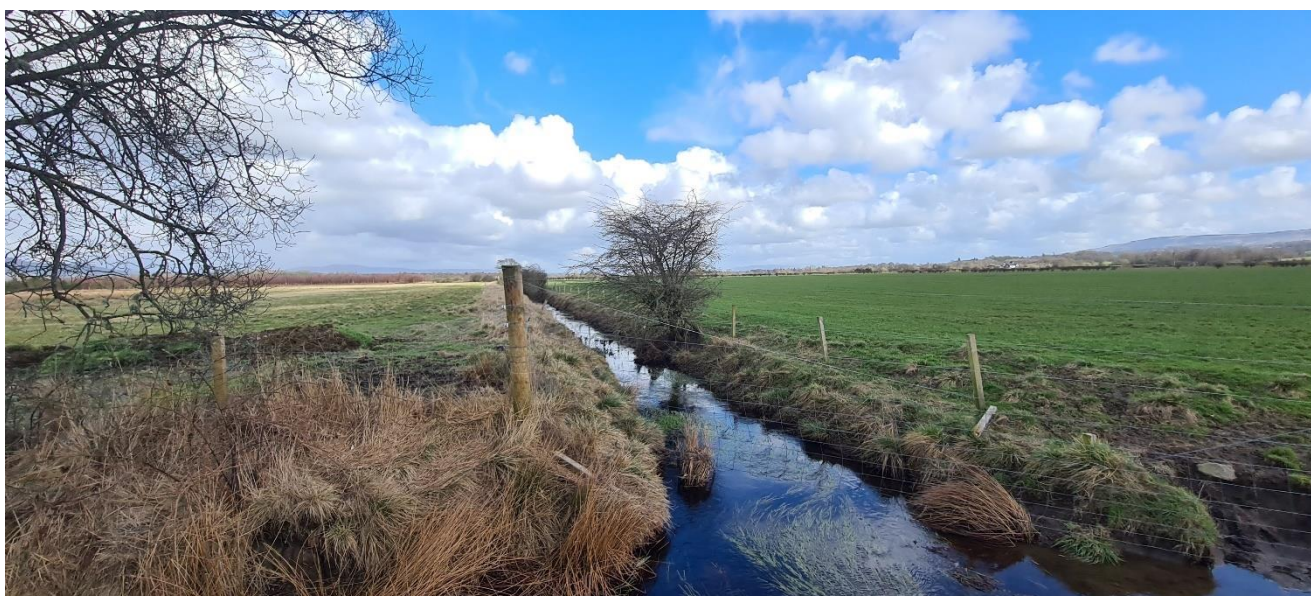
Figure 2-18 - Flanders Moss South - Large drain (Photograph 11)
