Russell Anderson's report on Leadburn Block

Visited on 4th and 11th December 2013

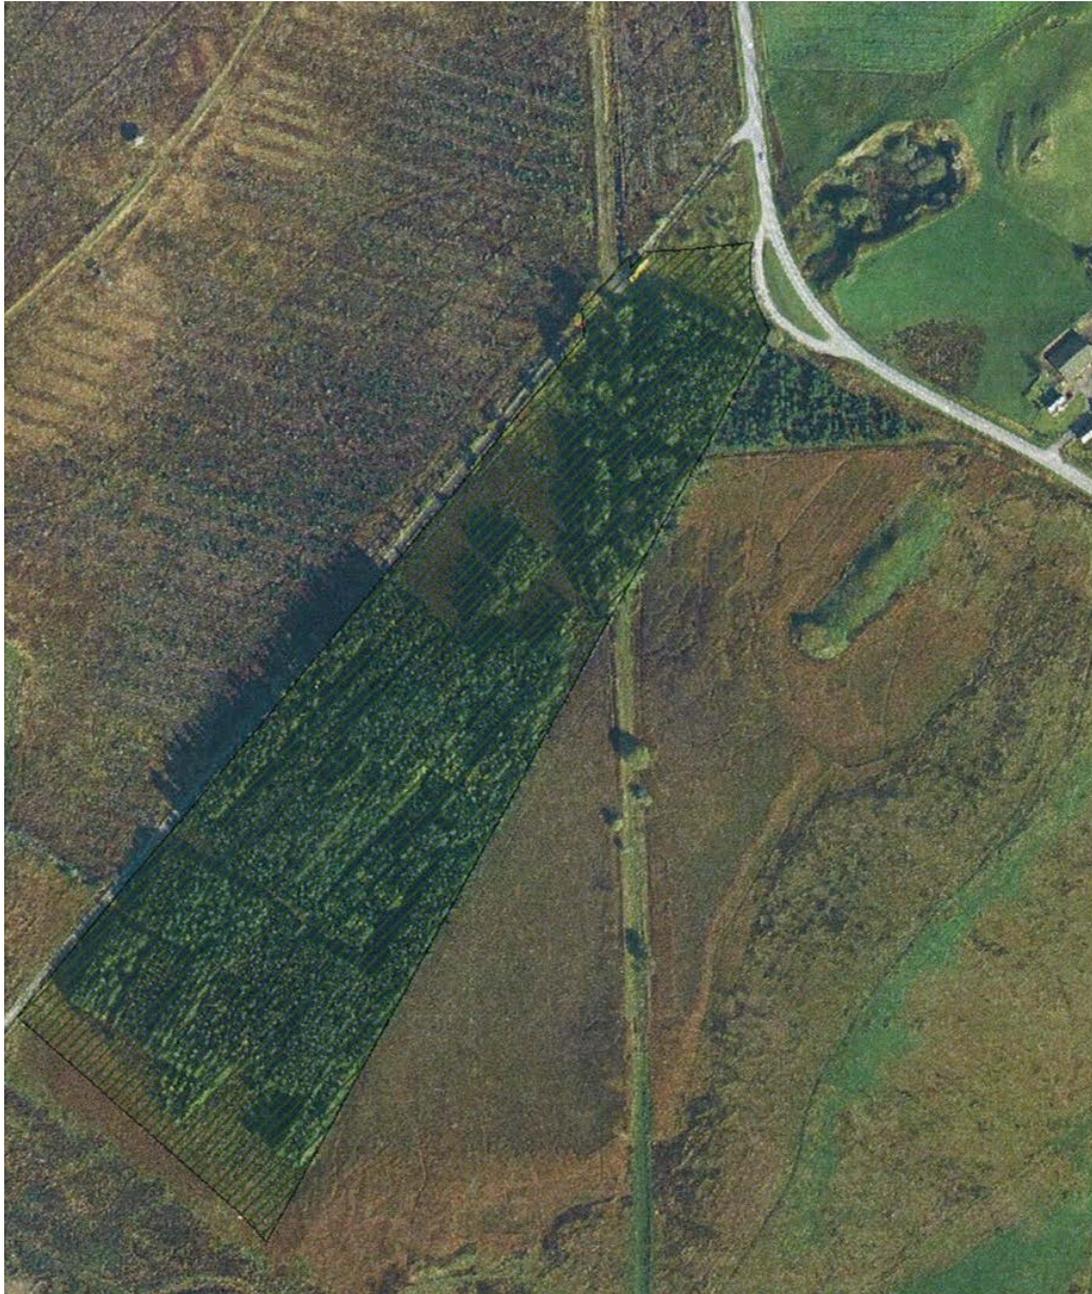
Within the FC fence, the main area of open ground is at the north end but there is also a ride aligned east to west part way down the block and some ploughed unplanted ground at the southern end (Figure 1). I also looked at unplanted ground on neighbouring land to the east to get another example of the vegetation potential of this peatland. Peatland immediately to the west, across the farm road, supports young, very open, mixed woodland and is managed as such by Leadburn Community Woodland Group.

Figure 1. 2007 air photo of the Leadburn block. The research area lies to the west of the N-S-running Leadburn to Peebles railway.
